Harper Creek Management Plan

FINAL Report
February 2013

Prepared for the
City of Peterborough by:

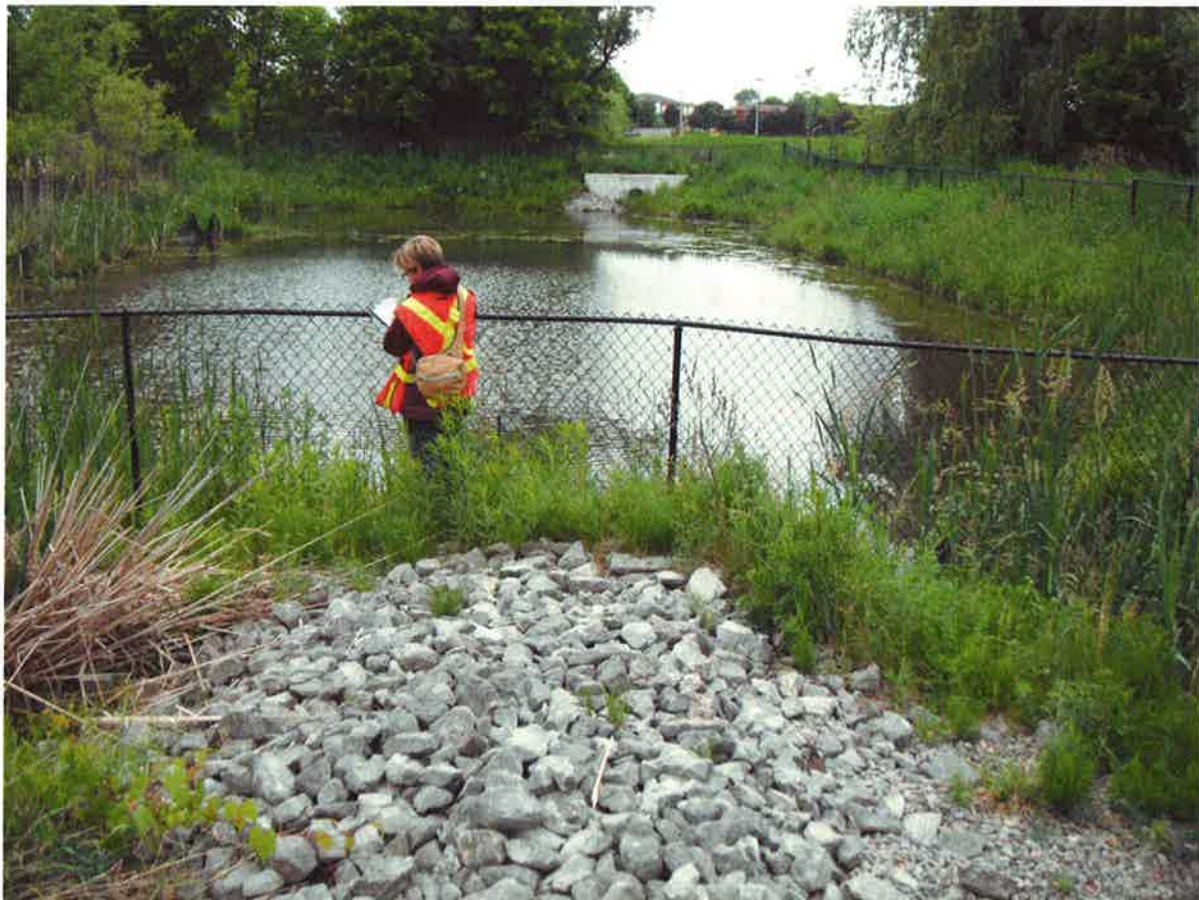
Reach 1 includes a storm water management pond (SWMP) located west of Dobbin Road (Figure 1). This Pond collects surface and piped storm water runoff from the Landsowne Street West area and is enclosed by a chain link fence and is situated within a cattail dominated, low-lying, wet area. Silt fencing was observed within the fenced enclosure on the west side of the pond.

Figure 1: Upstream view of Dobbin Street Storm Water Management Pond

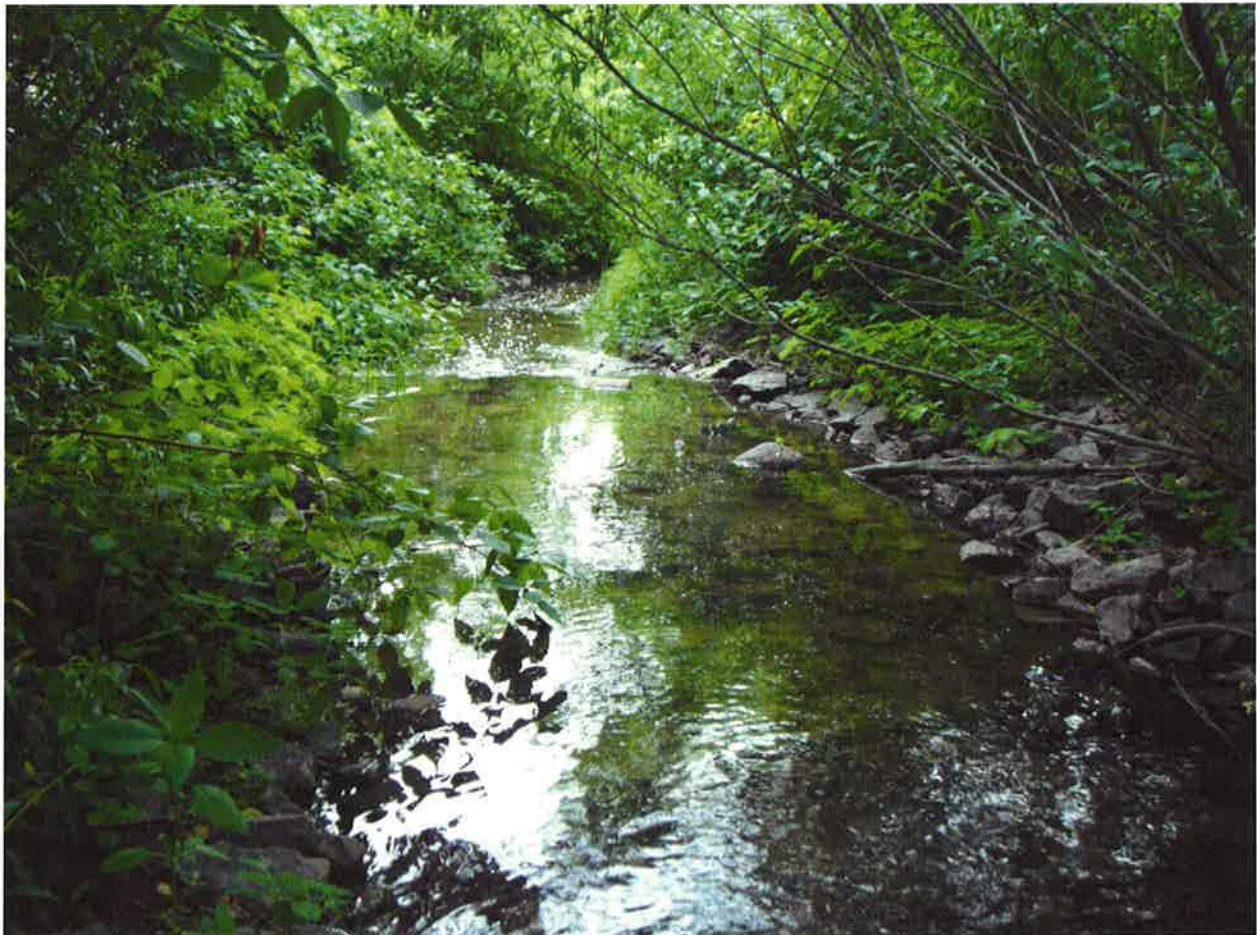
The initial section of Reach 2 between the SWMP outlet and Pinewood Drive is well vegetated with mature White Elm (*Ulmus laevis*), Basswood (*Tilia americana*), Manitoba Maple (*Acer negundo*) and willow species (*Salix spp.*) that provide up to 75% canopy cover (Figure 2). Other riparian vegetation includes Wild Grape, Jewelweed, Larger Bur Marigold (*Bidens laevis*) and Cup Plant. The stream morphology in this Reach is comprised of steps and pools with an approximate 2m wetted width and depth of 0.2 m. Aquatic vegetation includes Duckweed (*Lemna spp.*), Cattails (*Typha spp.*) and Watercress (*Nasturtium officinale*).

Figure 2: Downstream view from Stenson Storm Water Management Pond

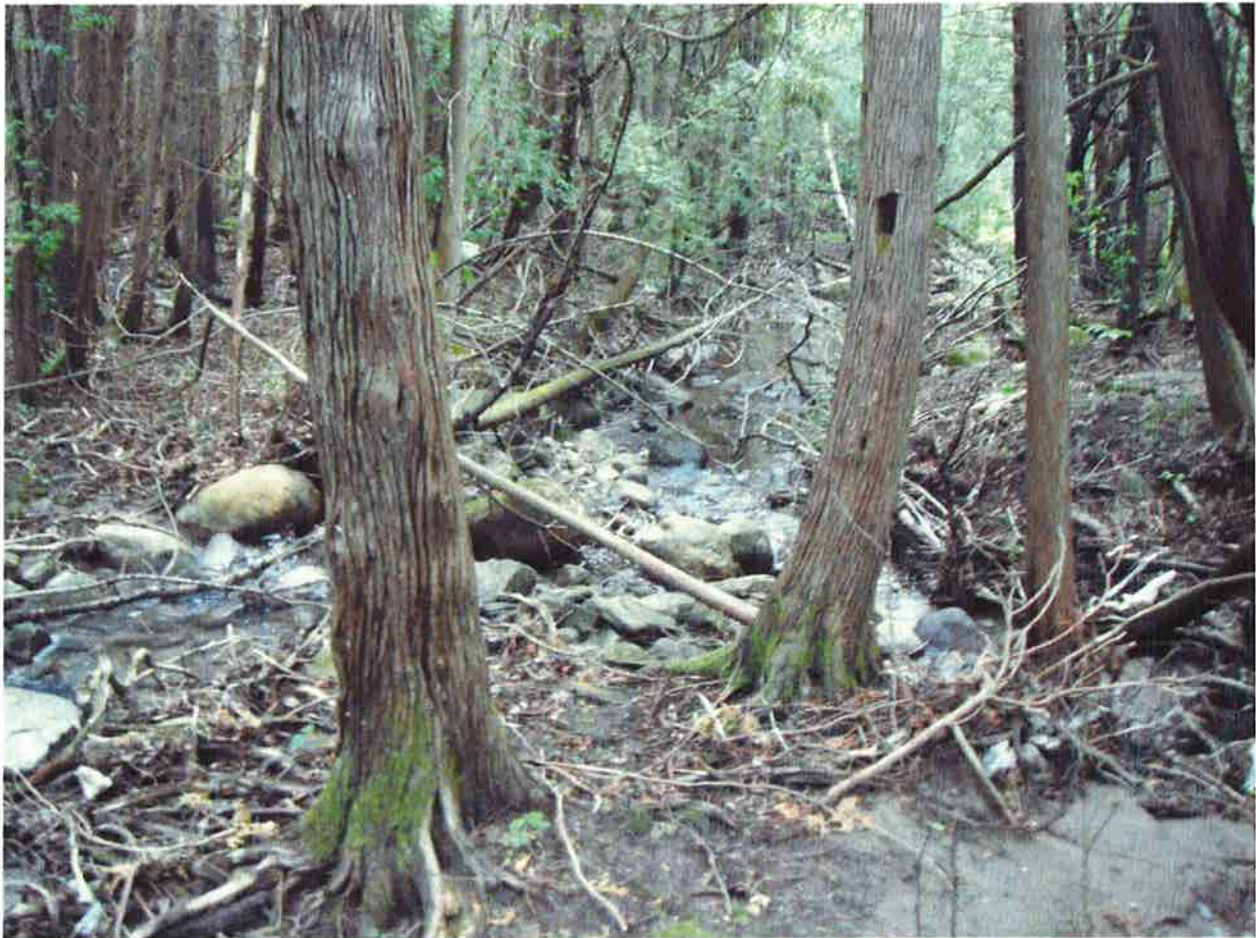
At “A”, the creek is braided, with most of the flow being directed along the northerly main channel in habitat similar to that described above (Figure 8).

Figure 8: Downstream view of Reach 6 at location marker *1 as shown on Map 10

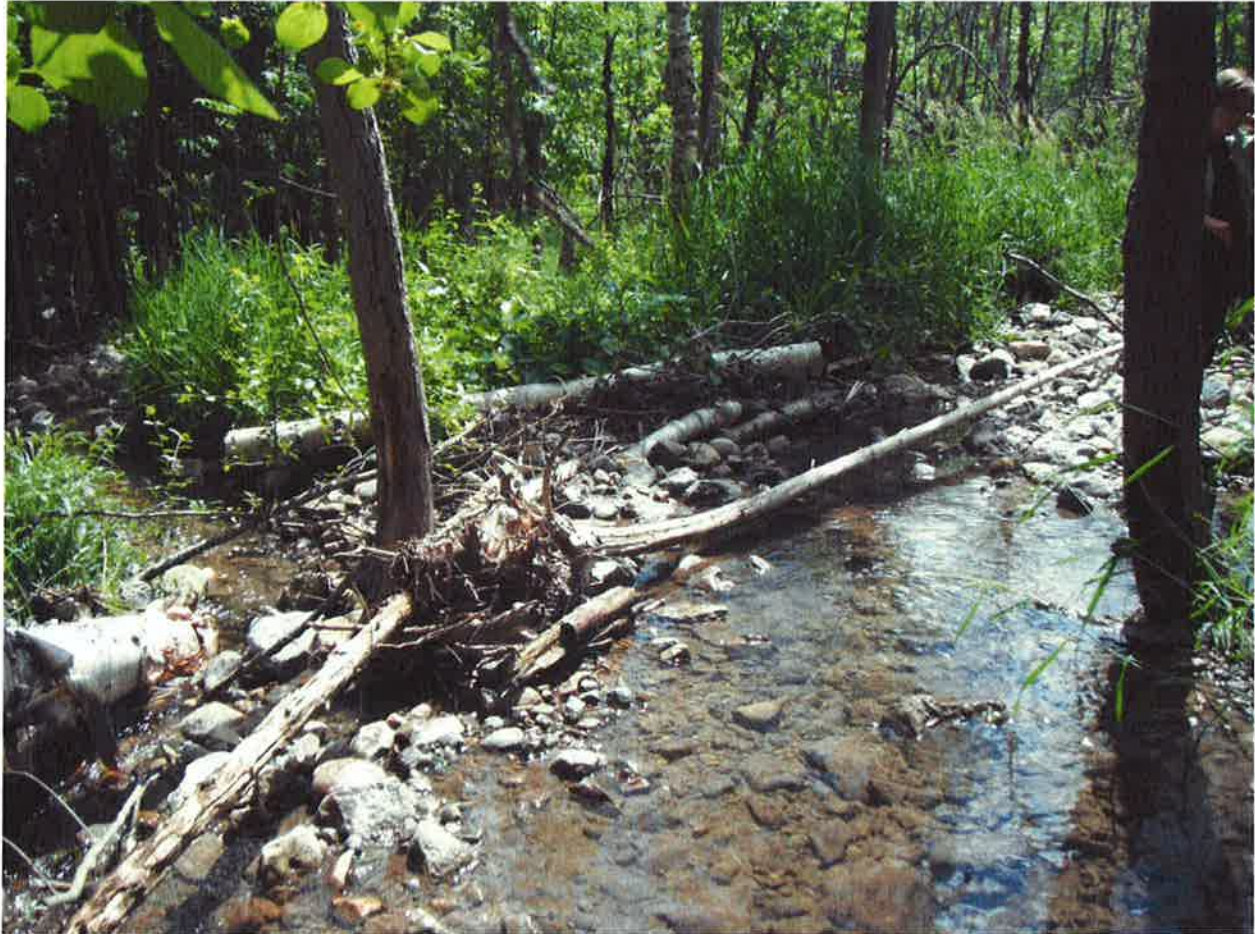
based on the abundant presence of standing dead trees. The channel wetted width averaged 1.5 m and natural meanders with riffles and pools were observed. Aquatic plant species along this section of the Reach include Watercress and Arrowhead (*Sagittaria spp.*) (Figure 10). This open meadow marsh riparian habitat persisted as the Creek flowed north of the City materials recycling yard. A small seep was apparent to the north of the main channel, west of the recycling yard where groundwater flowed through a very narrow channel that was indistinguishable in some areas.

Figure 9: Downstream view of Harper Creek at Marker *2 as shown on Map 10

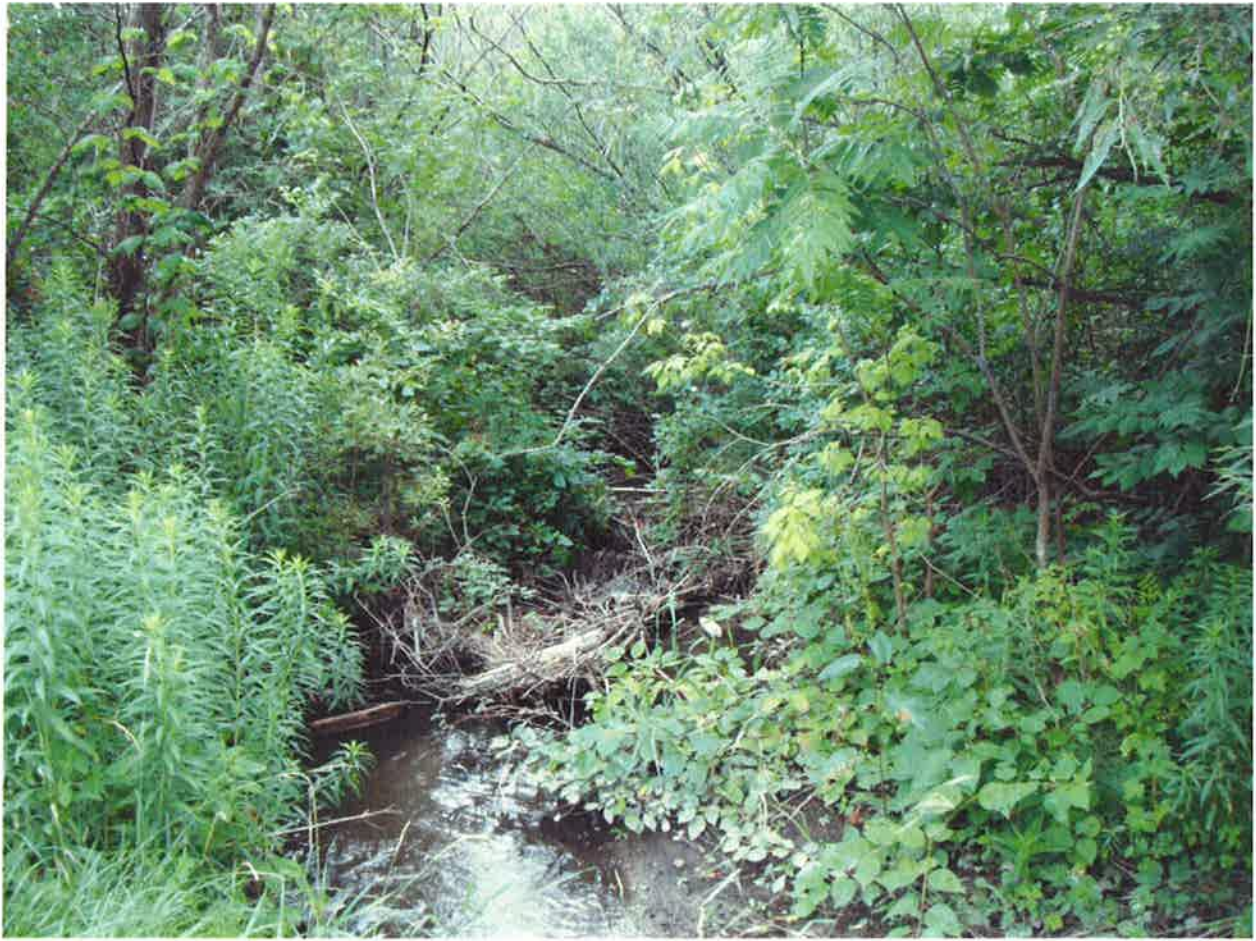
Riparian vegetation observed along Reach 7 includes Eastern White Cedar, Staghorn Sumac, Purple Loosestrife (*Lythrum salicaria* L.), Common Buckthorn, Tufted Vetch (*Vicia cracca* L.), Red Osier Dogwood (*Cornus stolonifera*), Canada Thistle (*Cirsium arvense*), Birdsfoot Trefoil, Green Amaranth (*Amaranthus viridis*), Nannyberry (*Viburnum lentago*), Common Elderberry, and Virginia Creeper (*Parthenocissus quinquefolia*). Wild Grape and Dog Strangling Vine (*Cynanchum rossicum*) were the dominant species along the railway embankment, and non-native species dominated the riparian area. Native species planting would enhance this area.

Figure 11: Downstream view of Reach 7

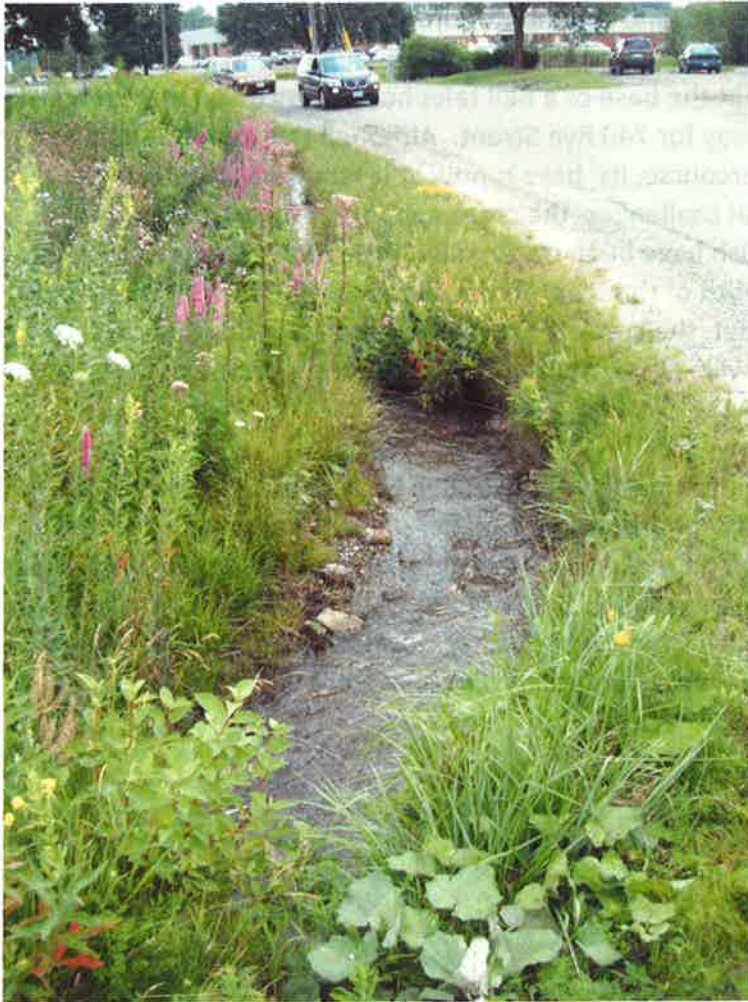
Upstream wetted widths in this section were approximately 0.45 m, widening to 1 m as it approaches to Rye Street. Gravel and cobble substrate was observed, with increasing amounts of sand closer to Rye Street. At Rye Street, the creek is redirected at a right angle and flows east along the north side of the road to Webber Avenue through a constructed channel that has gravel and sand substrates where cover varies from 0% to 50% (Figure 12).

Figure 12: Downstream view of Harper Creek along north side of Rye Street

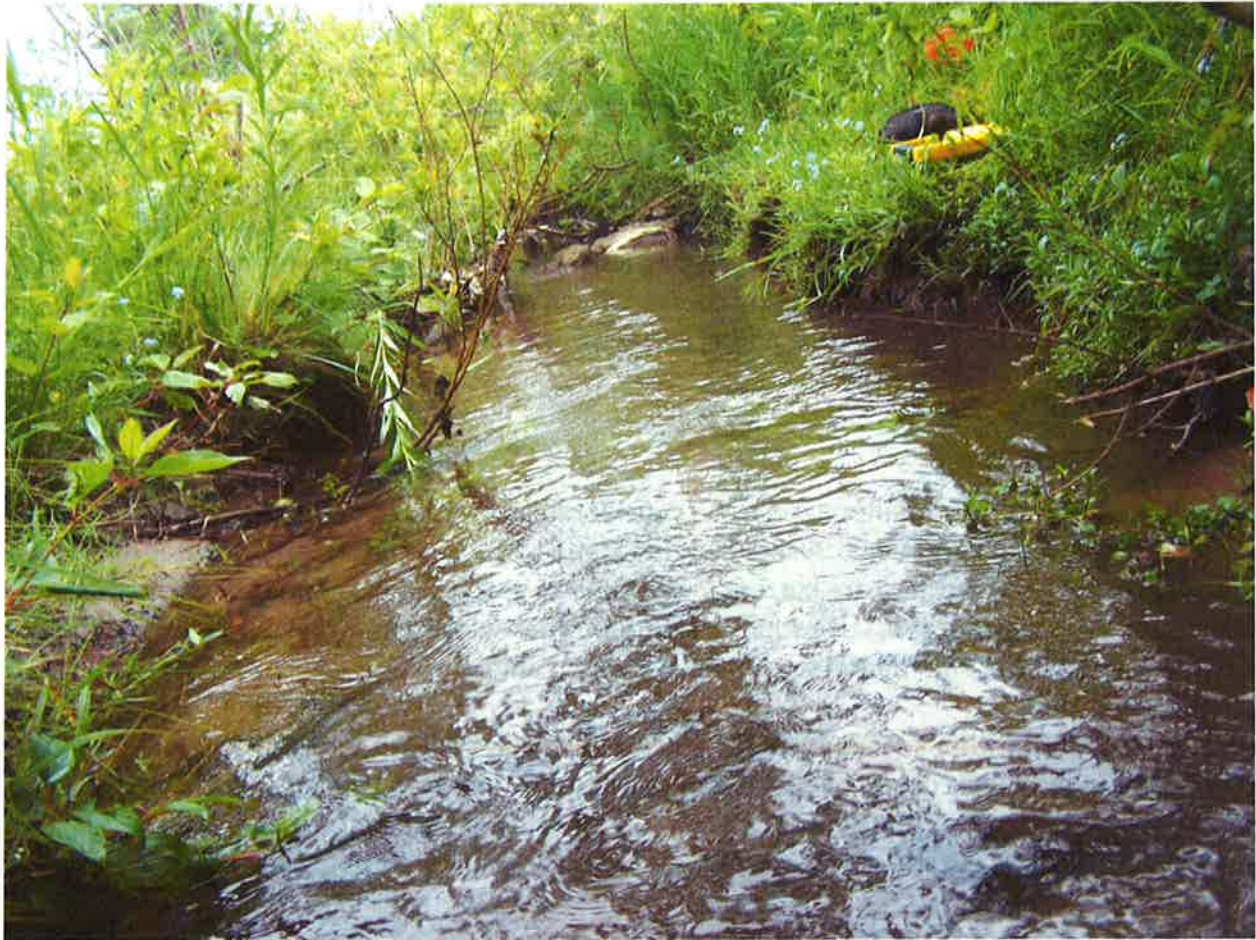
Riparian vegetation in Reach 9 was minimal in the vicinity of Rye Street and consisted of manicured grass and Dandelion (*Taraxacum officinale*). Further downstream along this reach, upstream of its confluence with Byersville Creek, riparian vegetation provides up to 100% cover and includes Common Buckthorn, Slender Willow (*Salix exigua*), White Ash, Eastern White Cedar, Basswood, Trembling Aspen, Tickle Grass (*Agrostis hyemalis*), Swamp Milkweed, Canada Goldenrod, Wild Grape, and Poison Ivy (*Toxicodendron radicans*) (Figure 13).

Figure 13: Downstream view of Reach 9

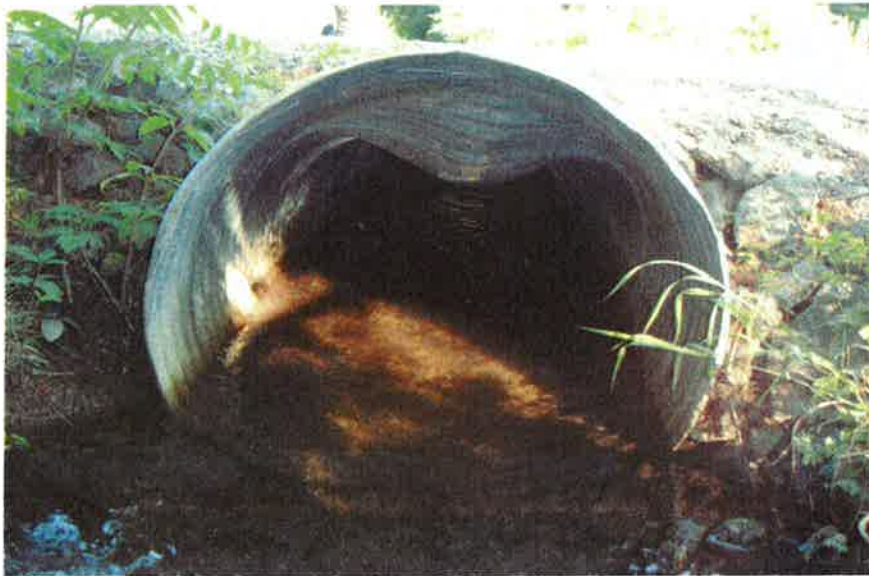
Downstream end of damaged culvert.

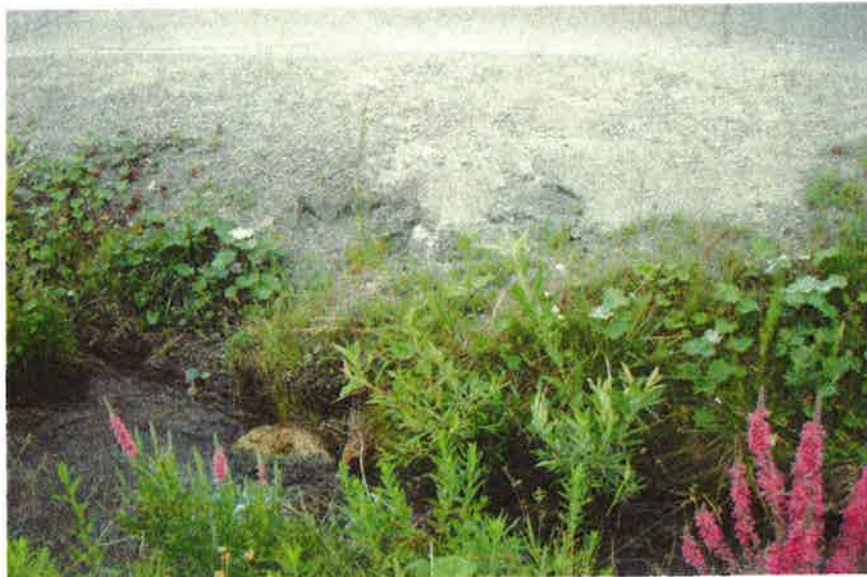
Stream bank erosion.
