Harper Creek Management Plan

FINAL Report
February 2013

Prepared for the
City of Peterborough by:

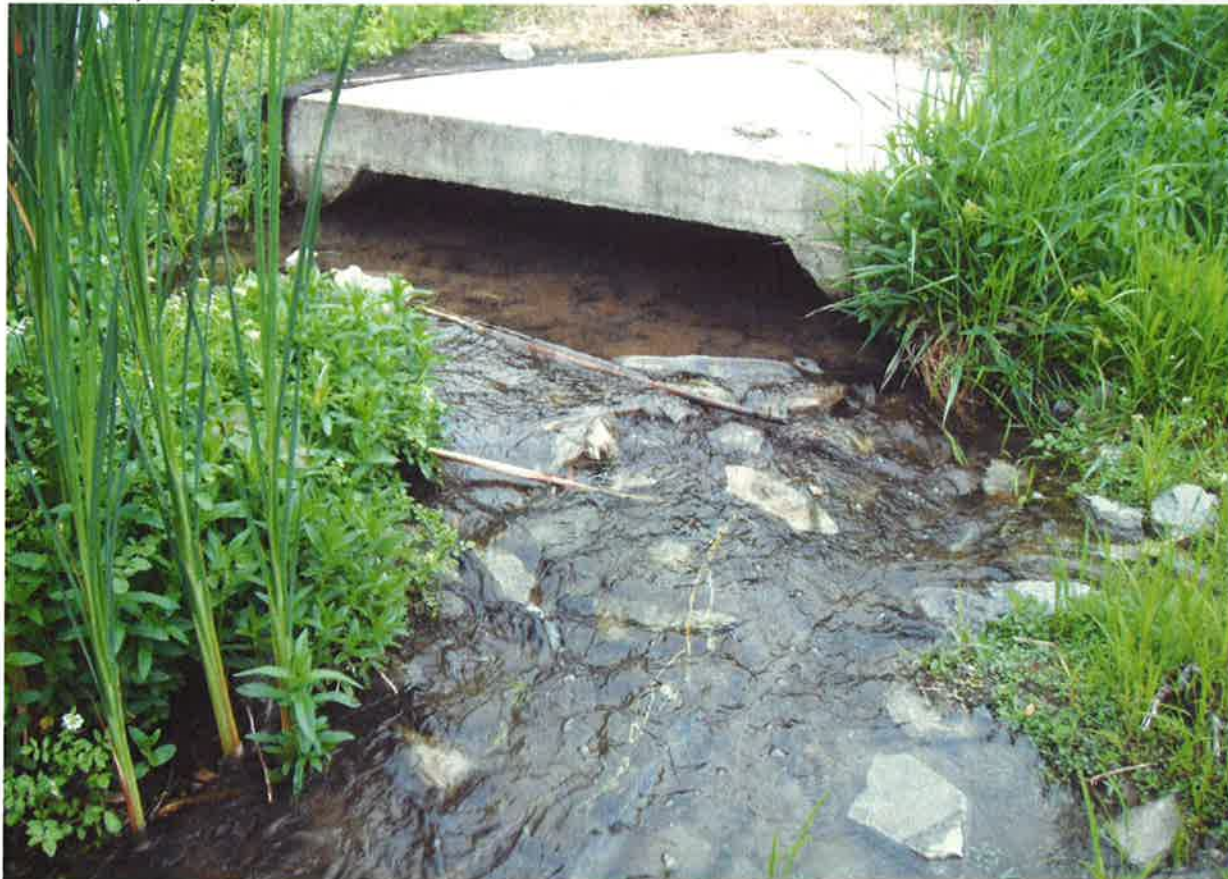
Figure 3: Downstream view of box culvert under Pinewood Road

Flow is conveyed under Pinewood Drive via a concrete box culvert which marks the beginning of the mid-section of this Reach (Figure 3). Surface water runoff from the west side of Pinewood Drive, north of the Creek, also flows under the road via this box culvert. Pinewood Drive is asphalt paved and has no curbs.

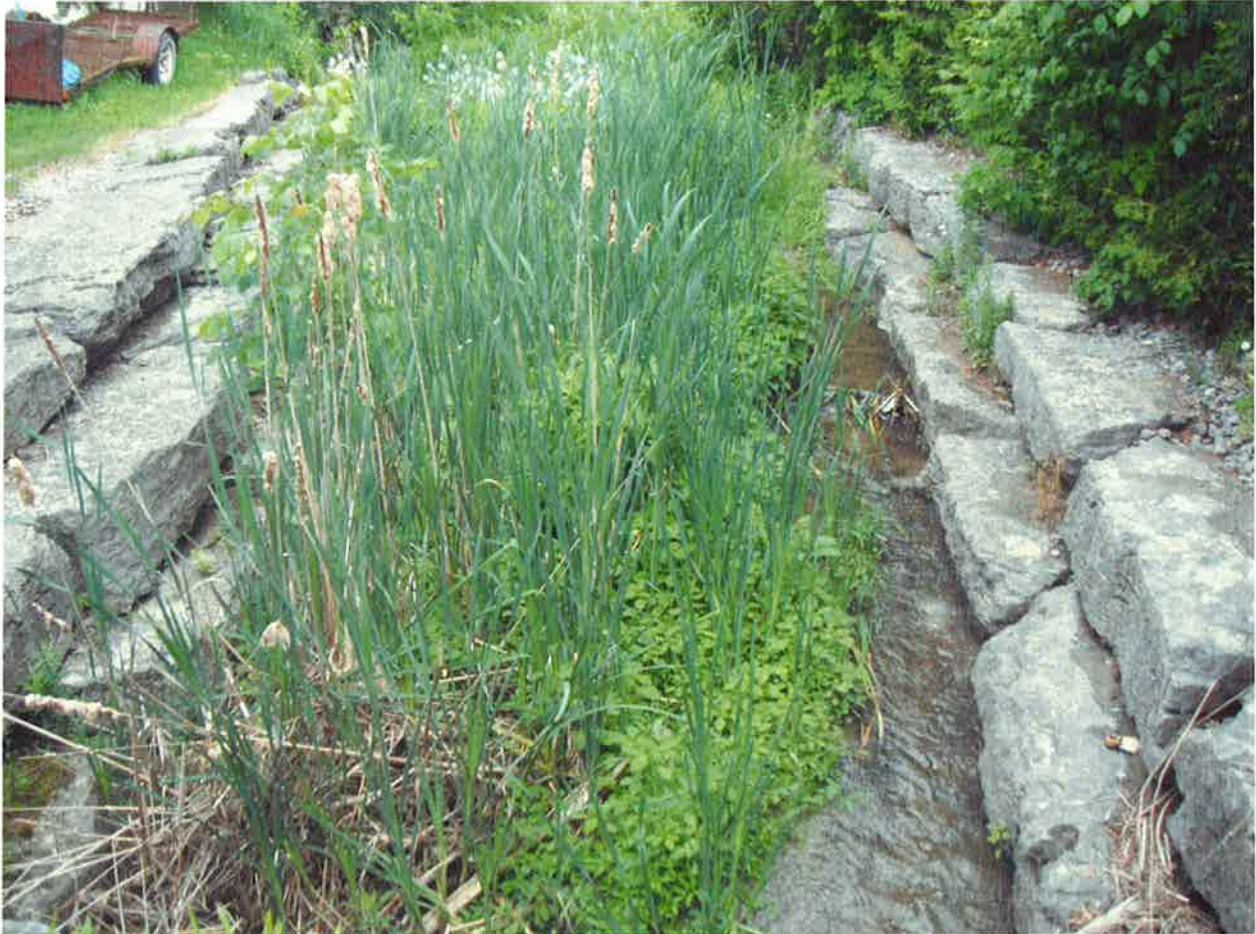
Figure 4: Upstream view of armour-stone lined channel, west of Spillsbury Drive

At the downstream end of Reach 2, flow is conveyed through an armour-stone lined section where Cattails, Goldenrod, Jewelweed and invasive Dame's Rocket (*Hesperis matronalis*) are

growing in areas of sand deposition within the channel (Figure 4). Flow is conveyed under Spillsbury Drive at which point it is piped underground to the concrete headwall located east of Bridlewood Park.

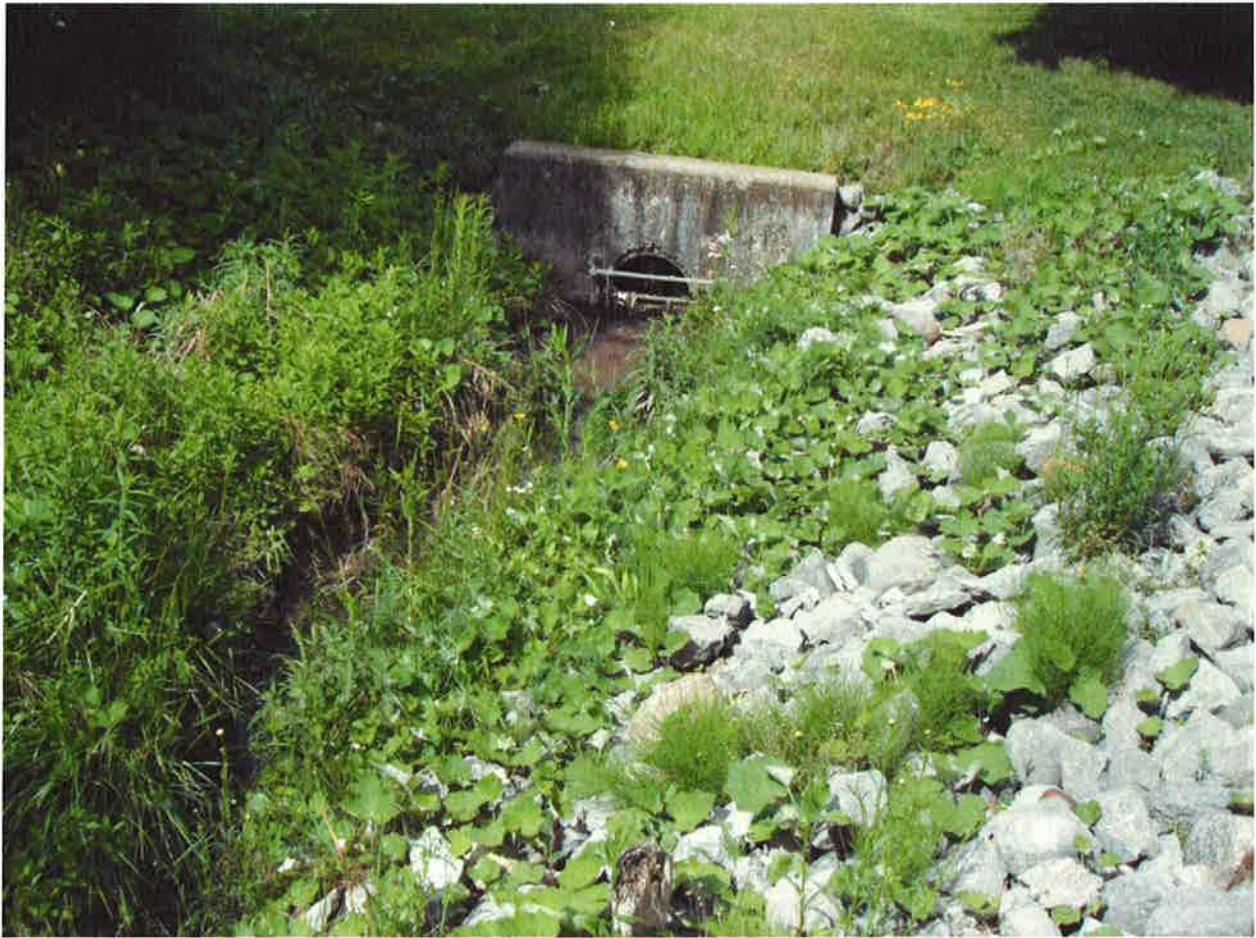
Figure 5: Upstream view of structure where Harper Creek daylights, east of Creekwood Drive

Between 155 and 151 Creekwood Drive a storm water outfall conveys water through a concrete

headwall into a channel with a sand substrate and rip rap lined banks (Figure 5). The creek in this area was approximately 0.1 m deep with a 0.5 to 1 m wetted width. Riparian vegetation in the open area between 155 and 151 Creekwood Drive includes a non-native White Mulberry tree (*Morus alba*), Willow, White Spruce (*Picea glauca*) and White Ash (*Fraxinus Americana*), while the ground-level vegetation consisted of Coltsfoot (*Tussilago farfara*), Watercress, Common Buckthorn, Jewelweed and Forget-me-not (*Myosotis Sylvatica*) and mown grass.

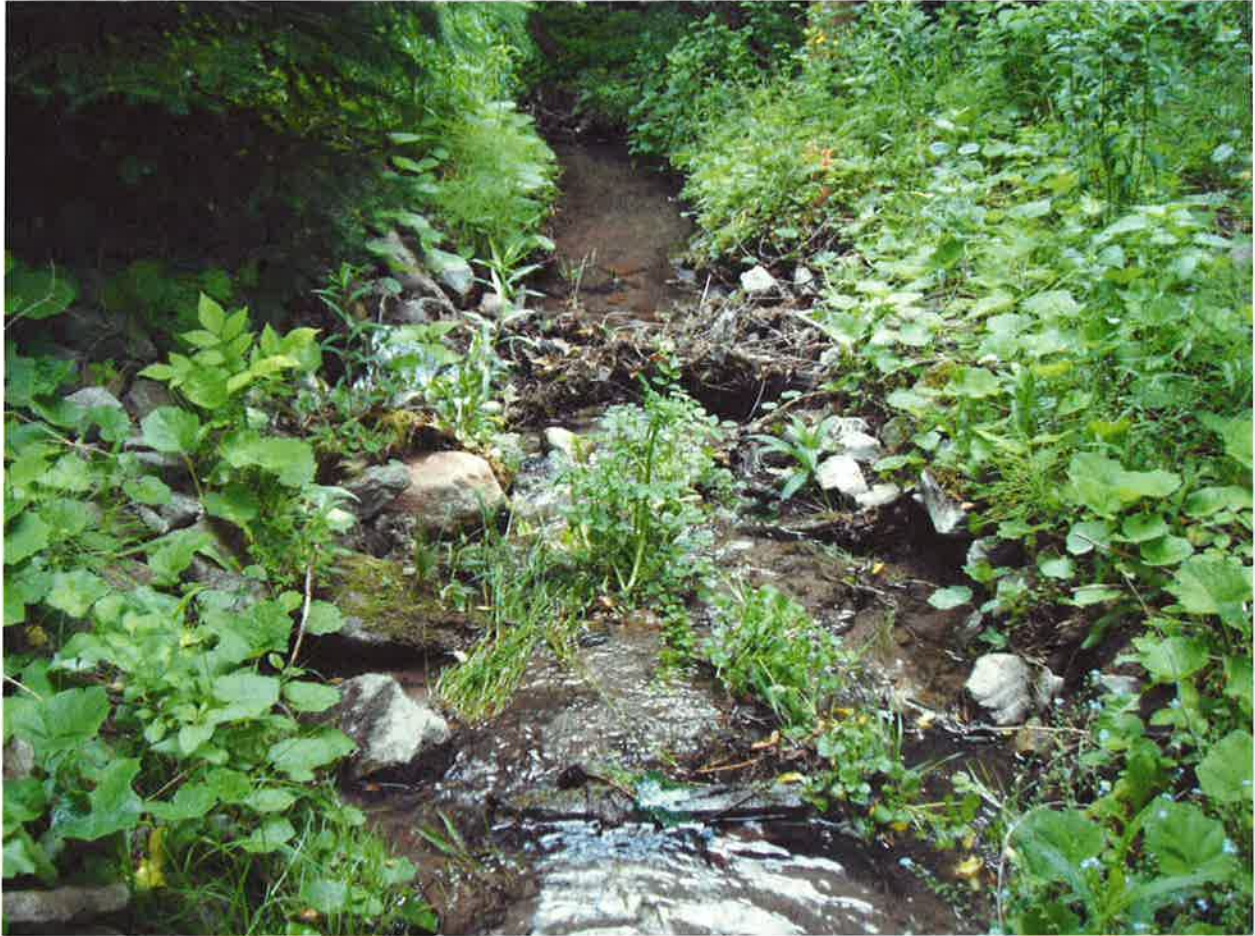
Figure 6: Downstream view of Harper Creek, east of Creekwood Drive

Beyond the manicured areas and rip rap lined channel, the Creek exhibits natural stream meanders, rounded cobble, boulder and gravel substrates and step/pool morphology (Figure 6). Clearings are characterized by Sensitive Fern (*Onoclea sensibilis* L.) and Horsetail, and treed areas are dominated by Eastern White Cedar. As this reach approaches the main channel, several braids are apparent, all of which exhibit undercut banks, coarse woody debris and deep pools of approximately 0.5 m.

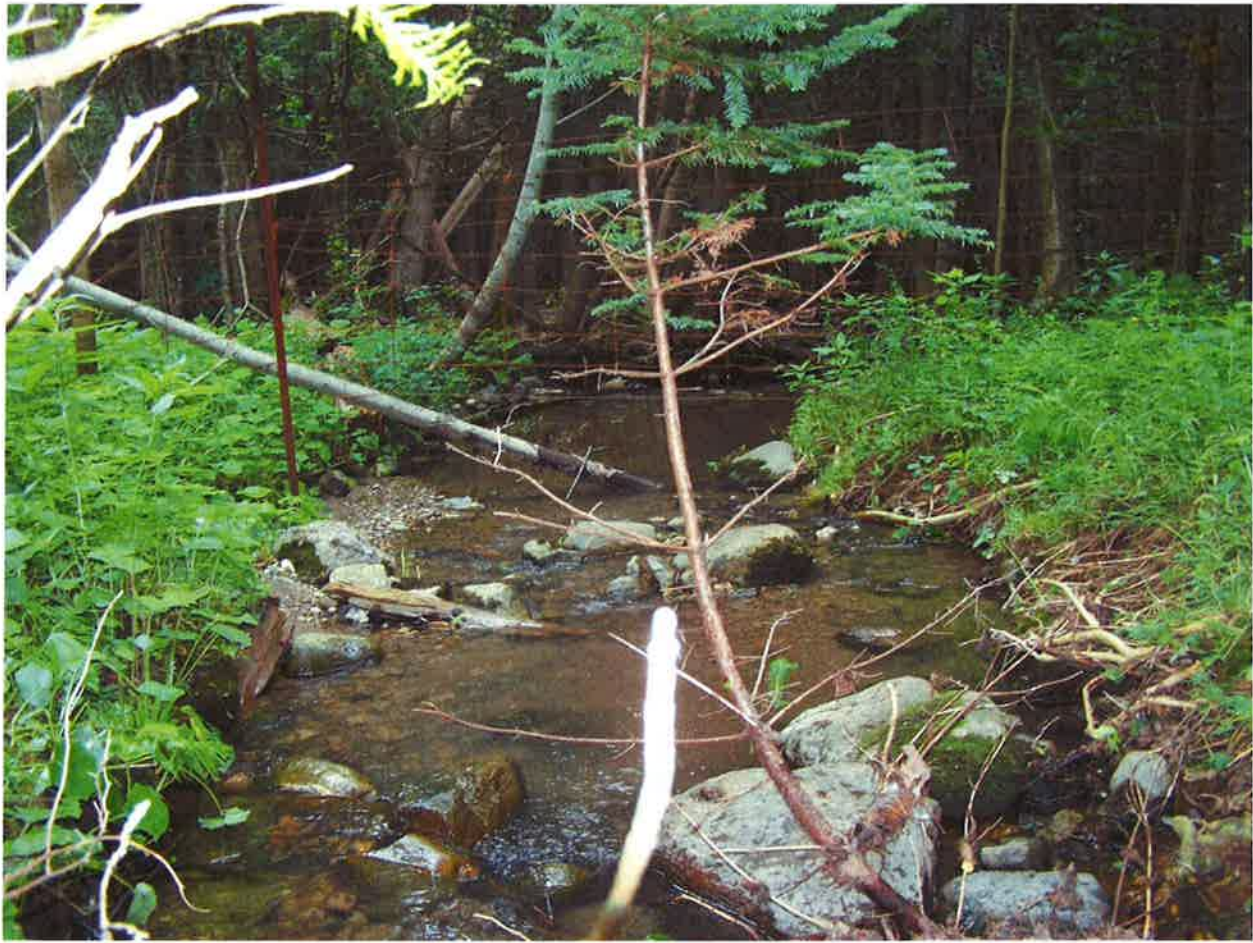
Figure 7: Downstream view of Reach 5

Reach 5 flows through the concrete wingwall/headwall structure on the east side of Bridlewood Park to the confluence with open water channel that originates east of Creekwood Drive and is identified as Reach 4. Water flows through a storm sewer outlet over a concrete flow dissipater and into a rounded river rock channel. Riparian vegetation in this open area is characterized by Goldenrod, Jewelweed, Coltsfoot, Green Amaranth (*Amaranthus viridis*), Watercress, Asters and Staghorn Sumac (*Rhus typhina*). As water flows east, it enters the Harper Creek Wetland where vegetative cover primarily consists of Eastern White Cedar, with Basswood and Sugar Maple (*Acer saccharum*) present. Ground cover includes Sensitive Fern, Spinulose Wood Fern (*Dryopteris carthusiana*), Beaked Sedge (*Carex utriculata*) and Jack-in-the-Pulpit (*Arisaema triphyllum*) (Figure 7). Reach 5 has an approximate wetted width of 2m and depth of 0.15 m.

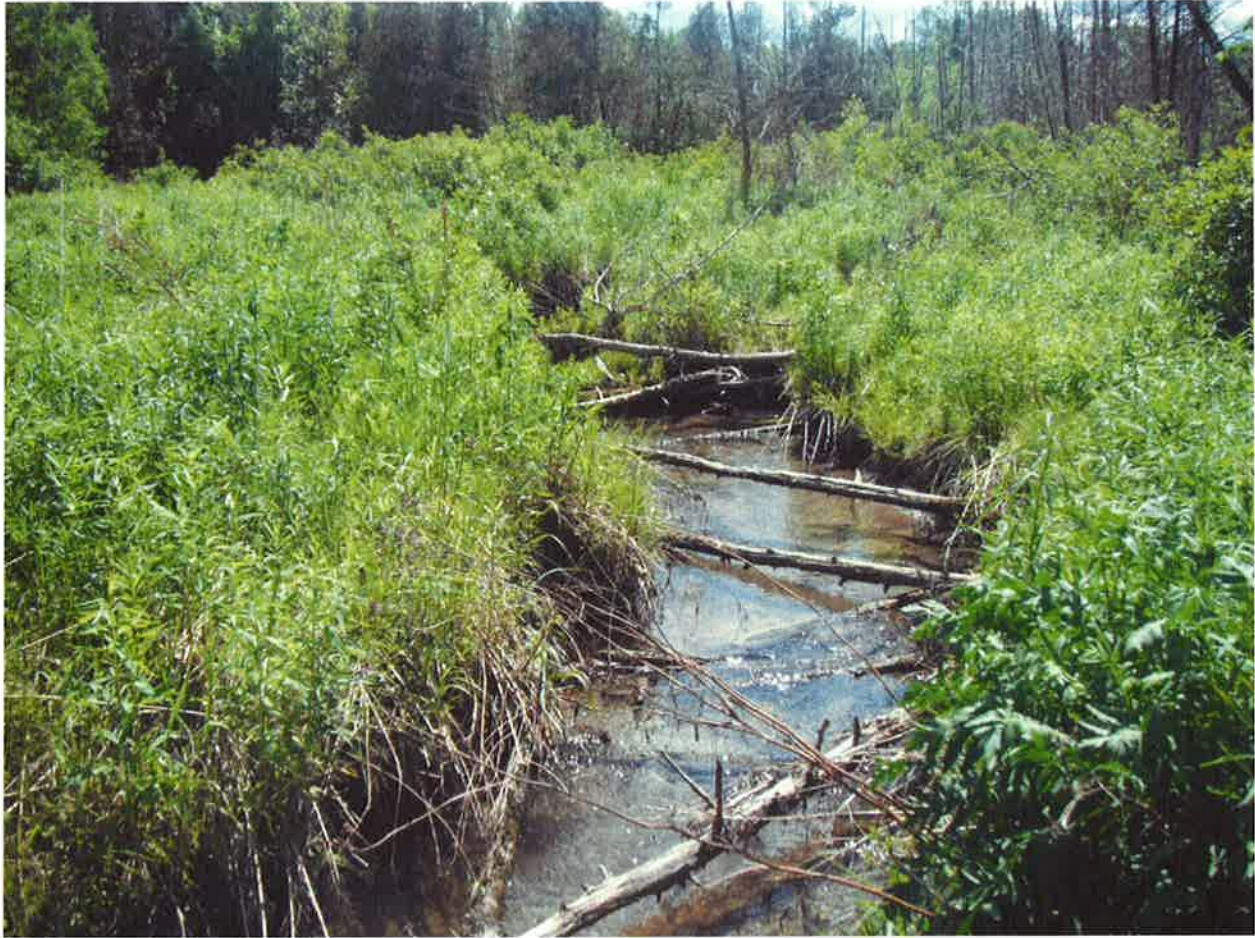
Figure 10: Upstream view of meadow marsh area, downstream of Marker *3 of Map 10

based on the abundant presence of standing dead trees. The channel wetted width averaged 1.5 m and natural meanders with riffles and pools were observed. Aquatic plant species along this section of the Reach include Watercress and Arrowhead (*Sagittaria spp.*) (Figure 10). This open meadow marsh riparian habitat persisted as the Creek flowed north of the City materials recycling yard. A small seep was apparent to the north of the main channel, west of the recycling yard where groundwater flowed through a very narrow channel that was indistinguishable in some areas.

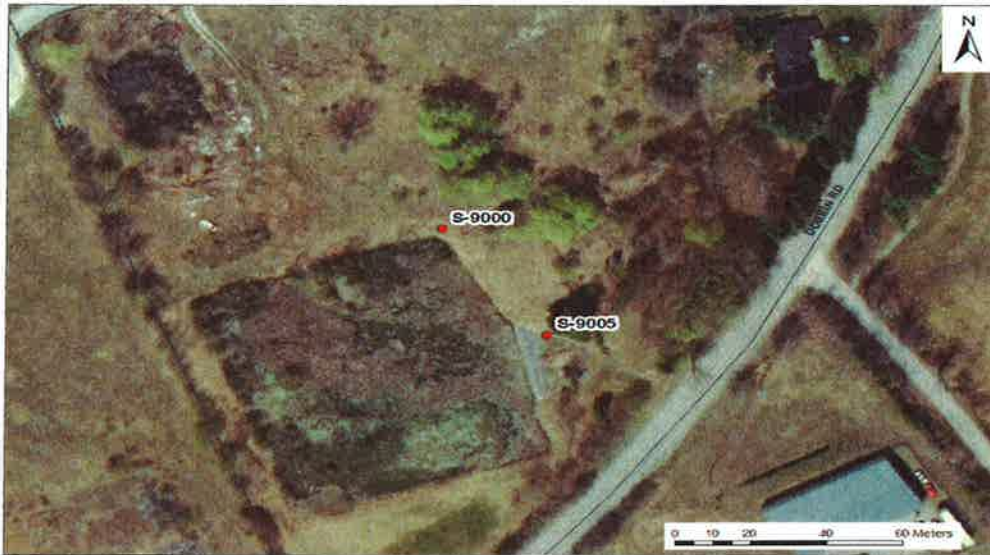
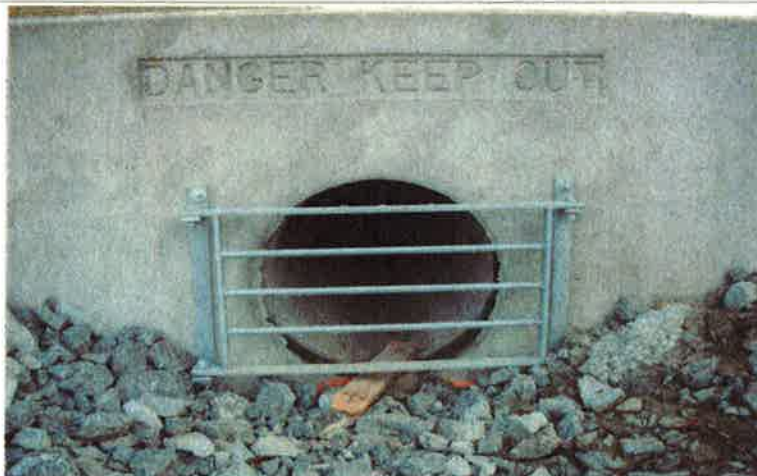
Structure Number S-9000 **Easting** 709306 **Northing** 4905783 **Stream Type** Cold
Stream Name Harper Creek **Location** Harper Creek at 453 Dobbin Road

Structure	Length	Year Built	Fish Observed	Public Land	<input checked="" type="checkbox"/>
Concrete Culvert	Unknown	Unknown	No	Private Land	<input type="checkbox"/>
Culvert 1 Rise	0.70m	Structure Condition	New		
Culvert 1 Span	0.70m	Problem Description	Structure in good condition, no issues.		
Culvert 2 Rise	none				
Culvert 2 Span	none	Work Permitted	June 1st - September 30th	Permit Required	Yes

Photo Description Storm sewer outfall culvert into stormwater management pond

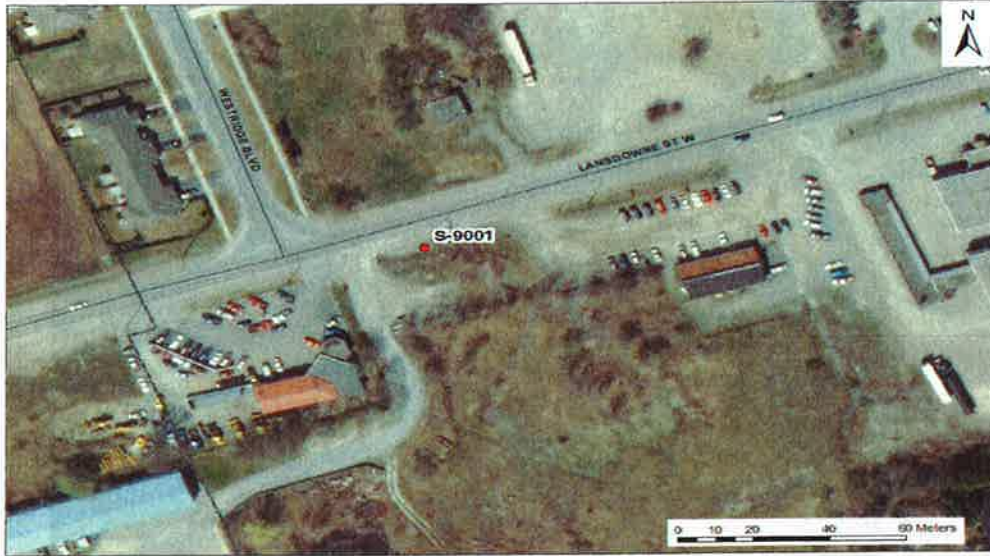
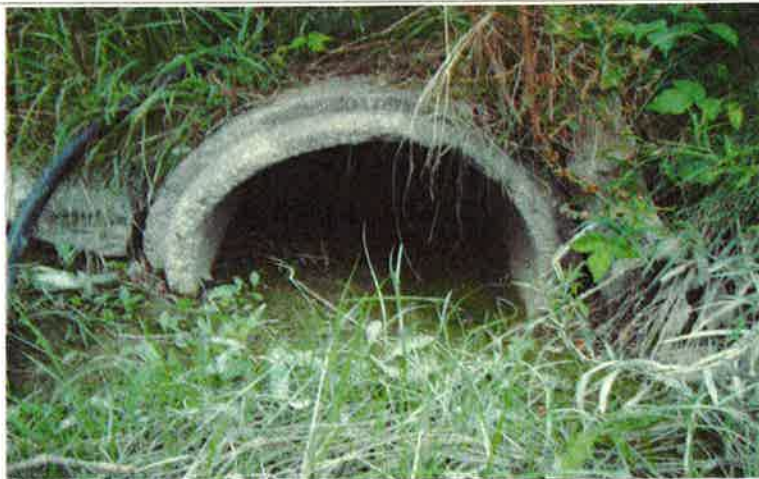
Structure Number S-9001 **Easting** 709266 **Northing** 4906167 **Stream Type** Cold
Stream Name Harper Creek **Location** Adjacent to 1931 Lansdowne Street West

Structure	Length	Year Built	Fish Observed	Public Land <input checked="" type="checkbox"/>
Concrete Culvert	Unknown	Unknown	No	Private Land <input type="checkbox"/>
Culvert 1 Rise	0.30m	Structure Condition	Good	
Culvert 1 Span	0.45m	Problem Description	Structure in good condition, no issues.	
Culvert 2 Rise	none			
Culvert 2 Span	none	Work Permitted	June 1st - September 30th	Permit Required Yes

Photo Description Road drainage inlet

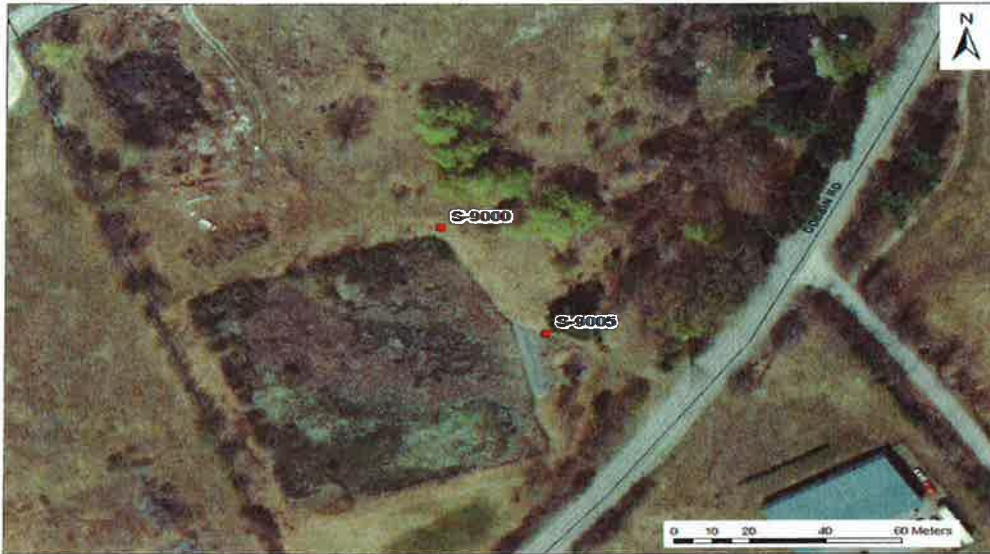
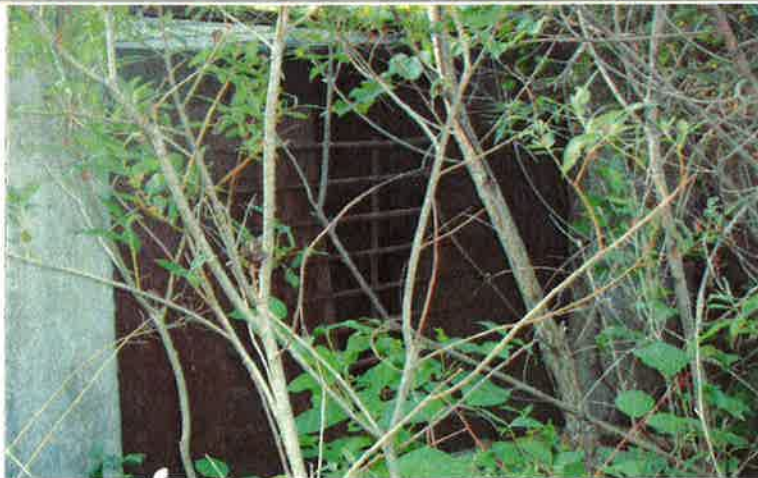
Structure Number S-9005 **Easting** 709334 **Northing** 4905445 **Stream Type** Cold
Stream Name Harper Creek **Location** Harper Creek at 453 Dobbin Road

Structure	Length	Year Built	Fish Observed	Public Land	<input checked="" type="checkbox"/>
Concrete Box Culvert	Unknown	Unknown	No	Private Land	<input type="checkbox"/>
Culvert 1 Rise	2.30m	Structure Condition	Good		
Culvert 1 Span	2.10m	Problem Description	Structure in good condition, no issues.		
Culvert 2 Rise	none				
Culvert 2 Span	none	Work Permitted	June 1st - September 30th	Permit Required	Yes

Photo Description Storm sewer inlet from stormwater management pond

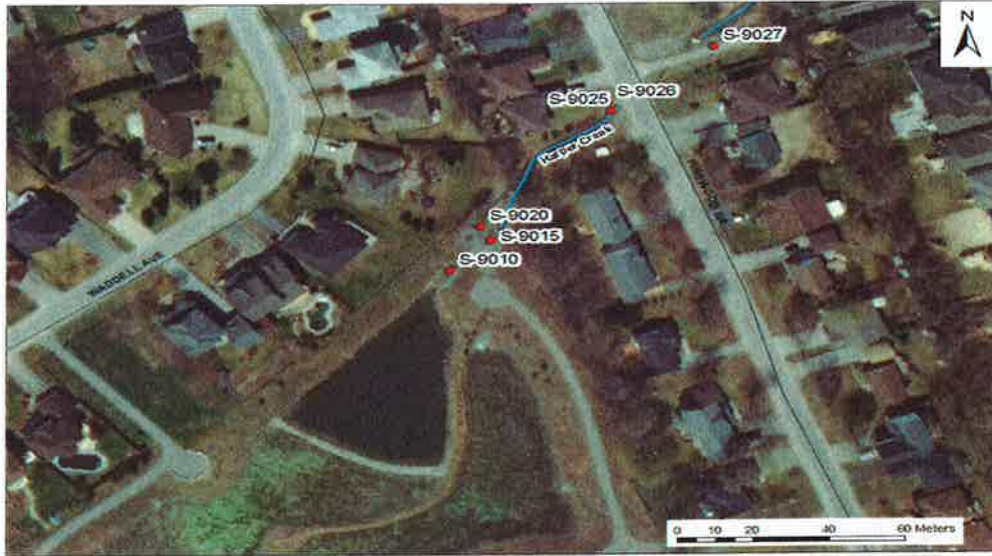
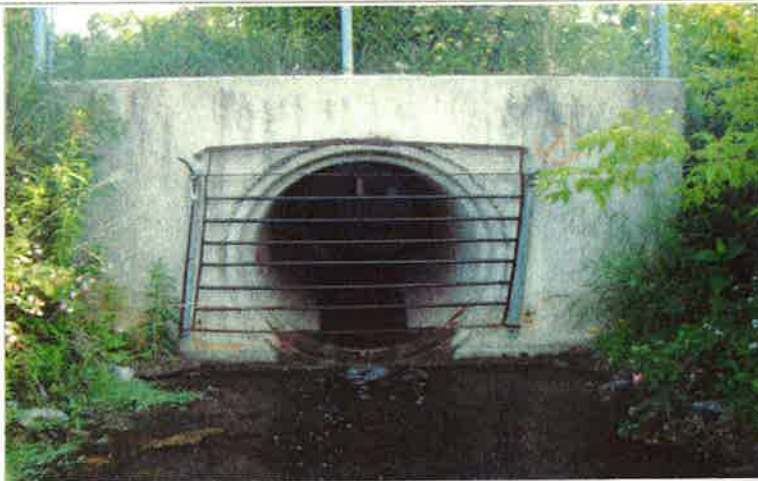
Structure Number **S-9010** Easting **710203** Northing **4905359** Stream Type **Cold**

Structure	Length	Year Built	Fish Observed	Public Land	<input checked="" type="checkbox"/>
Concrete Culvert	Unknown	Unknown	No	Private Land	<input type="checkbox"/>
Culvert 1 Rise	1.60m	Structure Condition	Good		
Culvert 1 Span	1.40m	Problem Description	Structure in good condition, no issues.		
Culvert 2 Rise	none	Work Permitted	June 1st - September 30th	Permit Required	Yes
Culvert 2 Span	none

Photo Description Storm sewer outfall into stormwater management pond

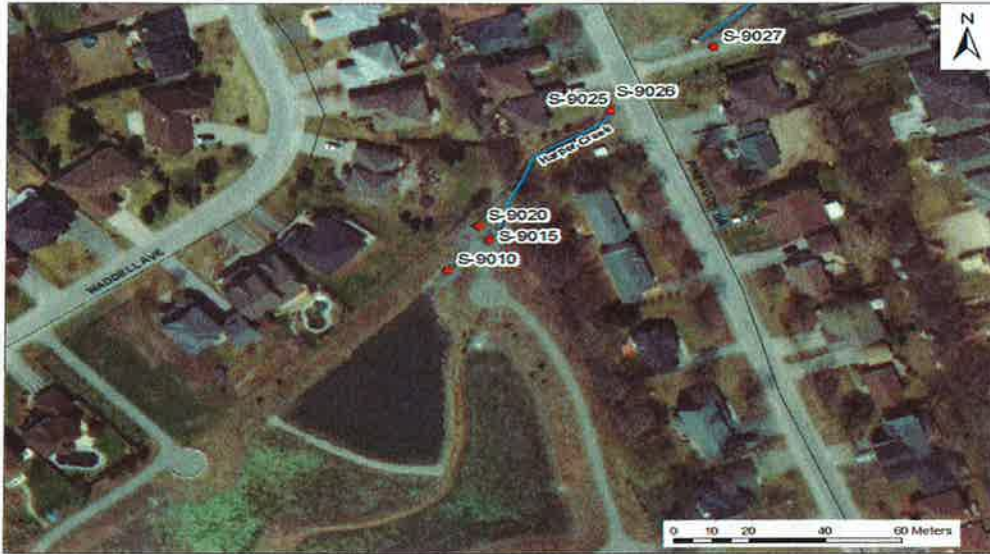
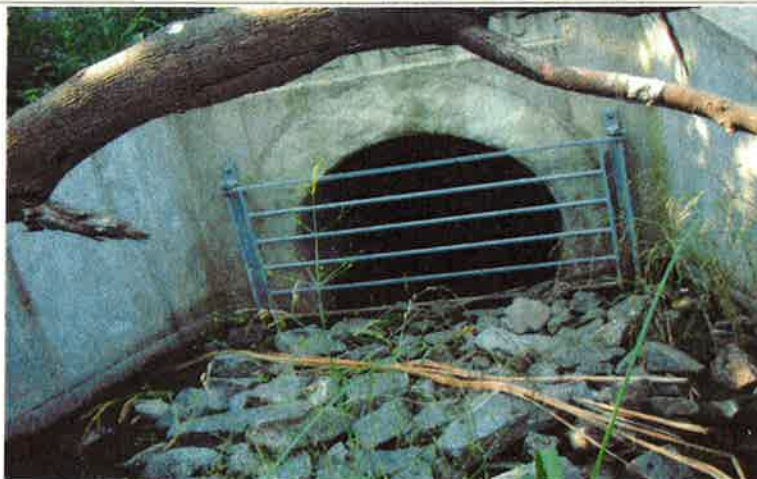
Structure Number S-9015 **Easting** 710214 **Northing** 4905370 **Stream Type** Cold
Stream Name Harper Creek **Location** Stenson Park located off Waddell Avenue

Structure	Length	Year Built	Fish Observed	Public Land	<input checked="" type="checkbox"/>
Concrete Culvert	Unknown	Unknown	No	Private Land	<input type="checkbox"/>
Culvert 1 Rise	1.00m	Structure Condition	Good		
Culvert 1 Span	1.00m	Problem Description	Structure in good condition, no issues.		
Culvert 2 Rise	none				
Culvert 2 Span	none	Work Permitted	June 1st - September 30th	Permit Required	Yes

Photo Description Stormwater management pond inlet

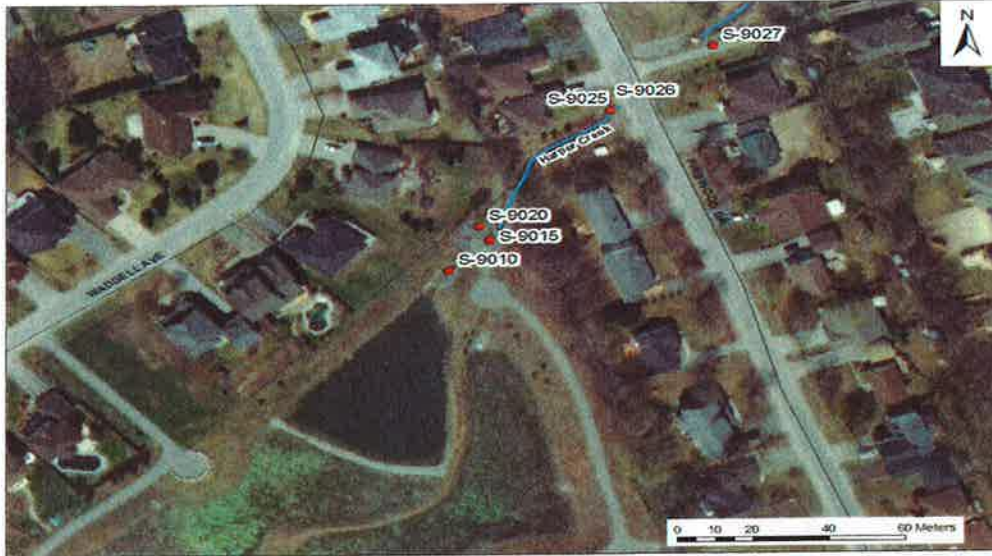
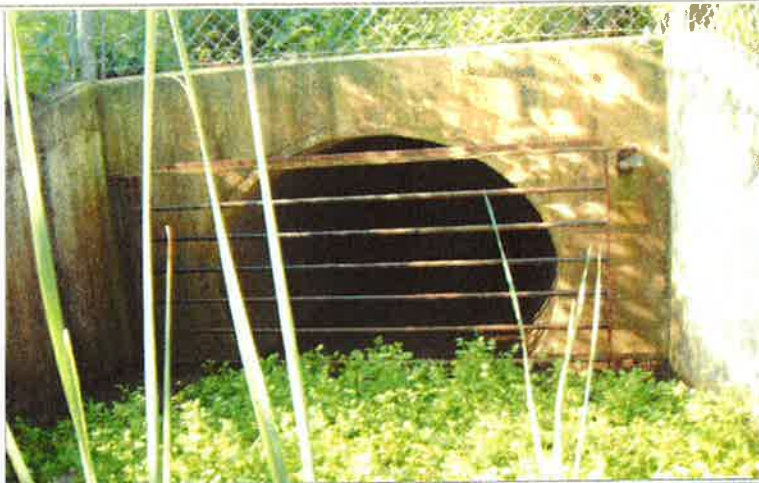
Structure Number **S-9020** Easting **710211** Northing **4905375** Stream Type **Cold**
Stream Name **Harper Creek** Location **Stenson Park located off Waddell Avenue**

Structure	Length	Year Built	Fish Observed	Public Land	<input checked="" type="checkbox"/>
Concrete Culvert	Unknown	Unknown	No	Private Land	<input type="checkbox"/>
Culvert 1 Rise	1.20m	Structure Condition	Good		
Culvert 1 Span	1.30m	Problem Description	Structure in good condition, no issues.		
Culvert 2 Rise	none	Work Permitted	June 1st - September 30th	Permit Required	Yes
Culvert 2 Span	none

Photo Description Storm sewer outfall

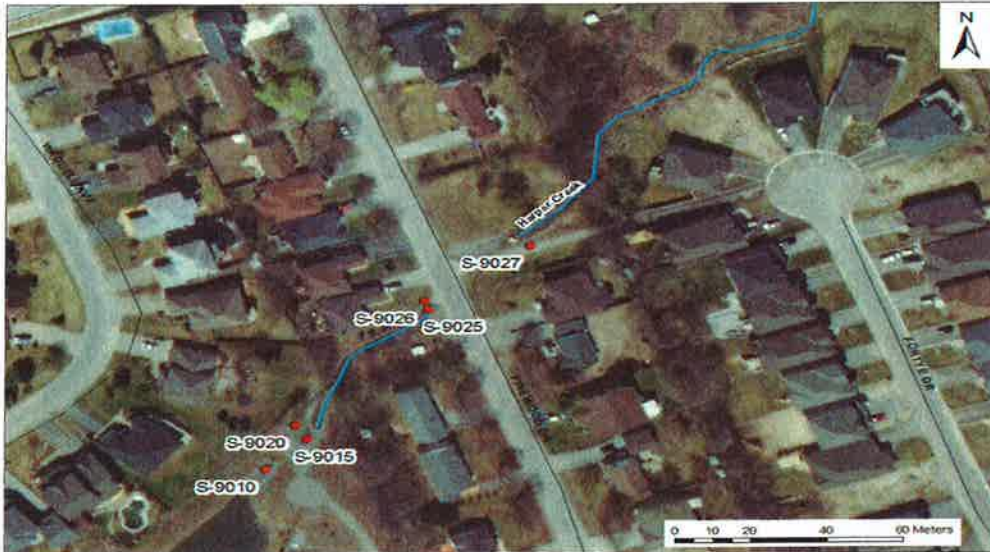
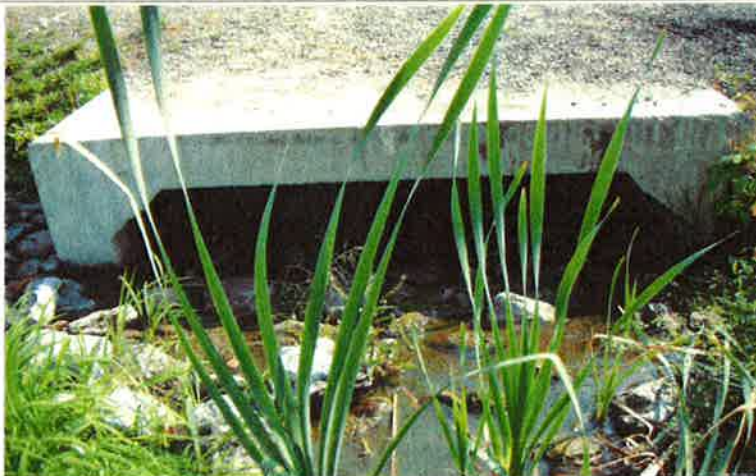
Structure Number S-9025 **Easting** 710246 **Northing** 4905417 **Stream Type** Cold
Stream Name Harper Creek **Location** Between 699 and 691 Pinewood Drive

Structure	Length	Year Built	Fish Observed	Public Land	<input checked="" type="checkbox"/>
Concrete Box Culvert	31.10m	Unknown	Yes	Private Land	<input type="checkbox"/>
Culvert 1 Rise	0.40m	Structure Condition	Good		
Culvert 1 Span	1.78m	Problem Description	Structure in good condition. Capacity limited due to height of culvert.		
Culvert 2 Rise	none				
Culvert 2 Span	none	Work Permitted	June 1st - September 30th	Permit Required	Yes

Photo Description Looking downstream at culvert

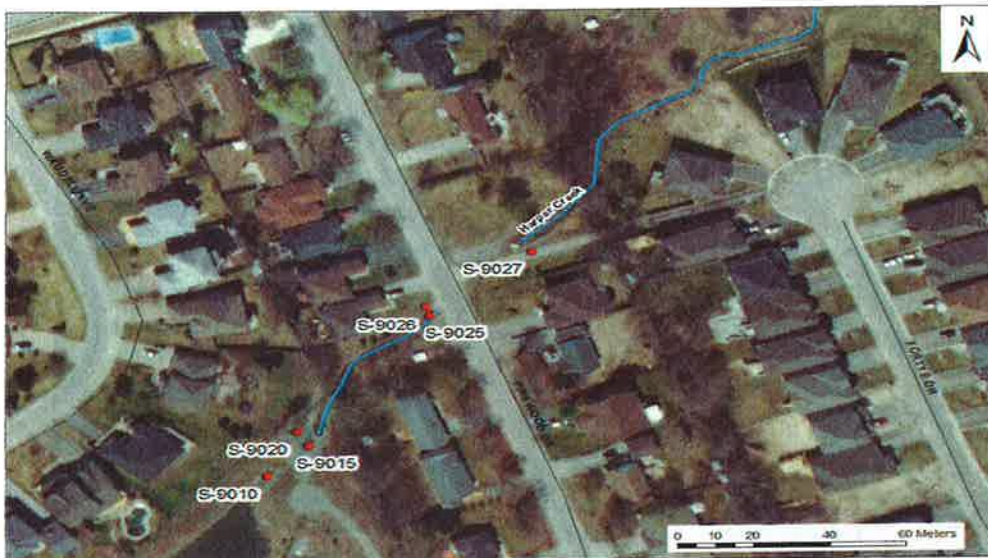
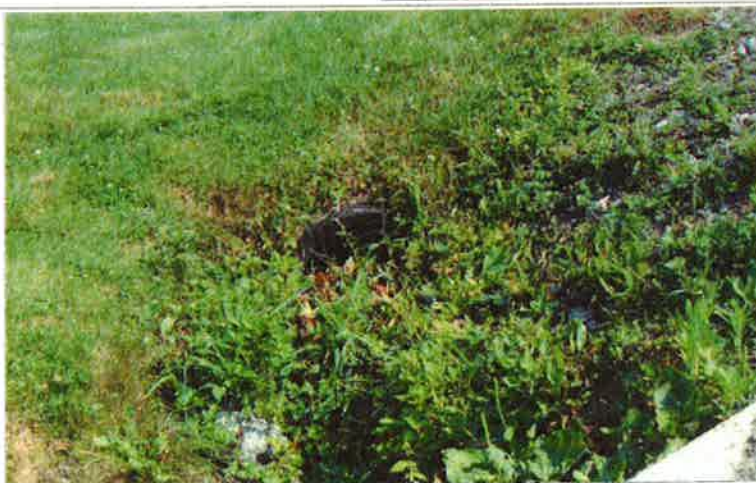
Structure Number S-9026 **Easting** 710245 **Northing** 4905420 **Stream Type** Cold
Stream Name Harper Creek **Location** 699 Pinewood Drive

Structure	Length	Year Built	Fish Observed	Public Land
PVC	11.20m	Unknown	Yes	<input type="checkbox"/>
Culvert 1 Rise	0.30m	Structure Condition	Good	
Culvert 1 Span	0.30m	Problem Description	Structure in good condition, no issues.	
Culvert 2 Rise	none			
Culvert 2 Span	none	Work Permitted	June 1st - September 30th	Permit Required Yes

Photo Description Driveway ditch drainage into Harper Creek

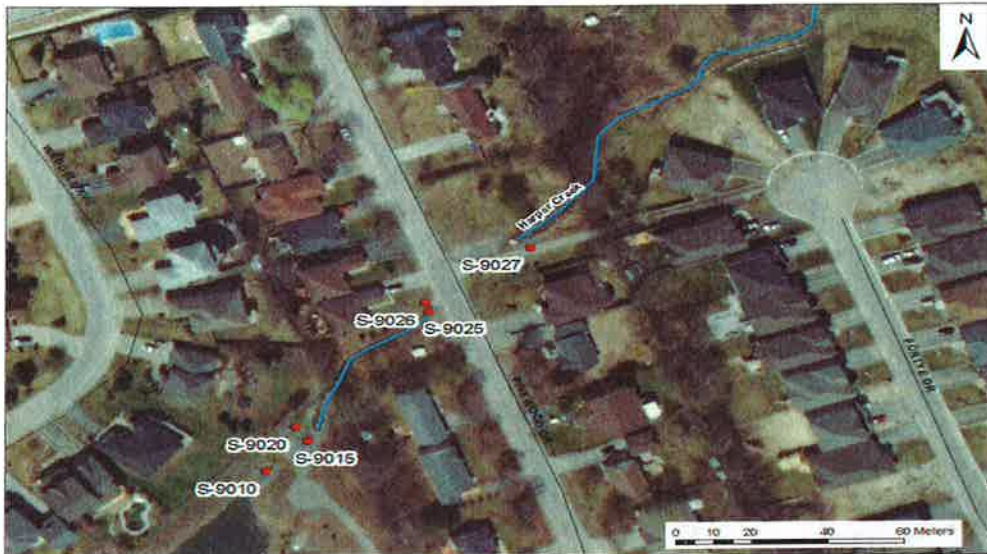
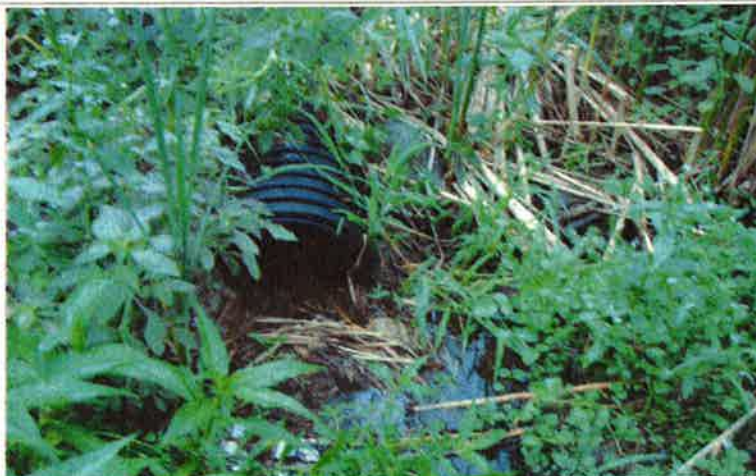
Structure Number S-9027 **Easting** 710273 **Northing** 4905440 **Stream Type** Cold

Structure PVC **Length** 10.50m **Year Built** Unknown **Fish Observed** Yes **Public Land** ☒ **Private Land** ☐

Culvert 1 Rise 0.35m **Structure Condition** Good

Culvert 1 Span 0.35m **Problem Description** Structure in good condition, no issues.

Photo Description Pavement drainage into Harper Creek

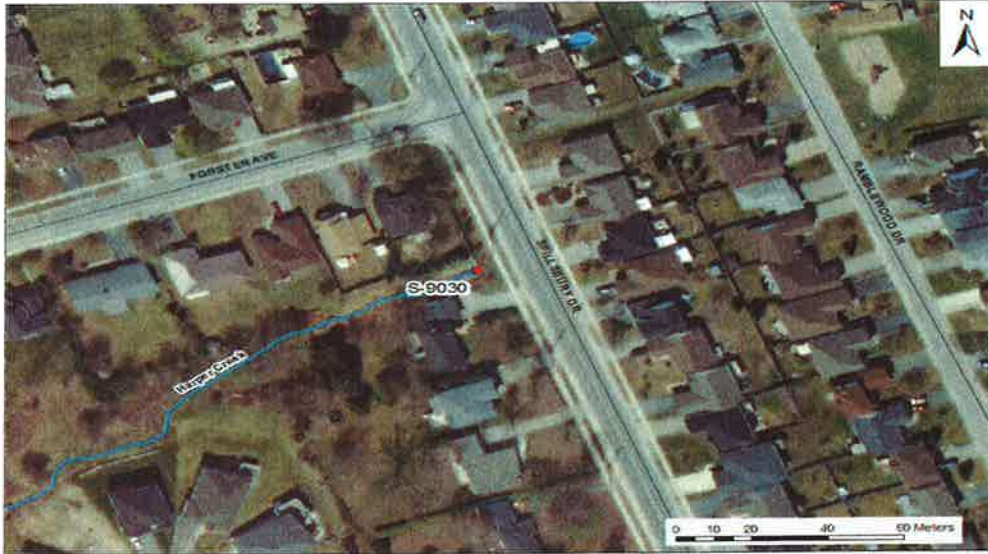
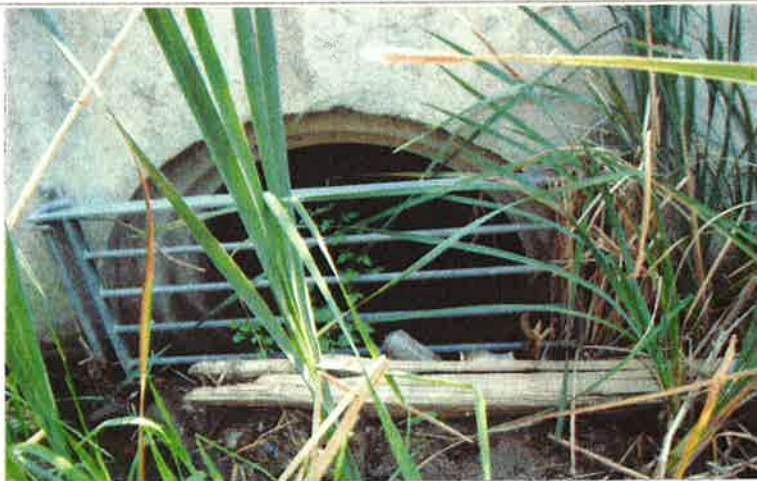
Structure Number S-9030 **Easting** 710423 **Northing** 4905576 **Stream Type** Cold
Stream Name Harper Creek **Location** Harper Creek adjacent to 717 Spillsbury Drive

Structure	Length	Year Built	Fish Observed	Public Land	<input checked="" type="checkbox"/>
Concrete Culvert	Unknown	Unknown	Yes	Private Land	<input type="checkbox"/>
Culvert 1 Rise	0.77m	Structure Condition	Good		
Culvert 1 Span	0.90m	Problem Description	Structure in good condition, no issues.		
Culvert 2 Rise	none				
Culvert 2 Span	none	Work Permitted	June 1st - September 30th	Permit Required	Yes

Photo Description Culvert inlet

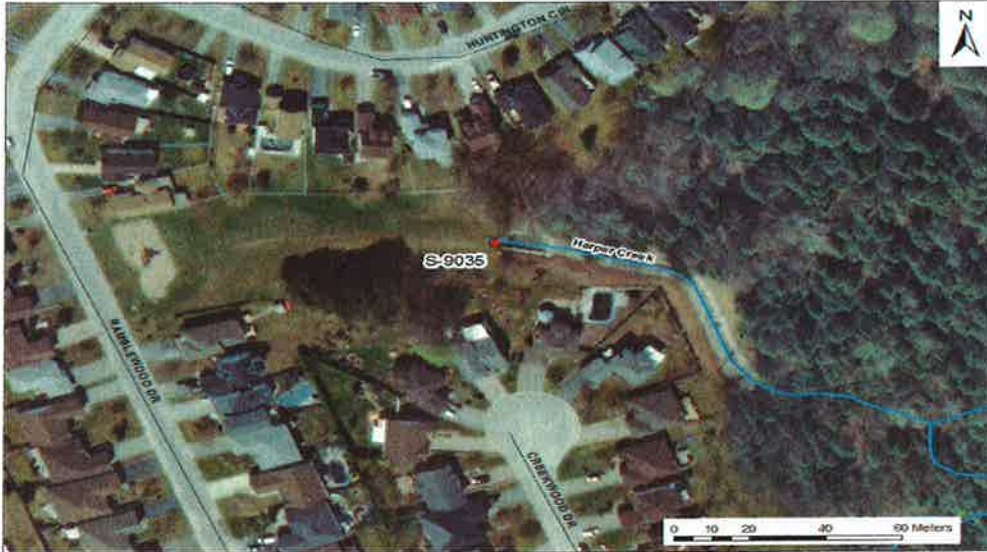
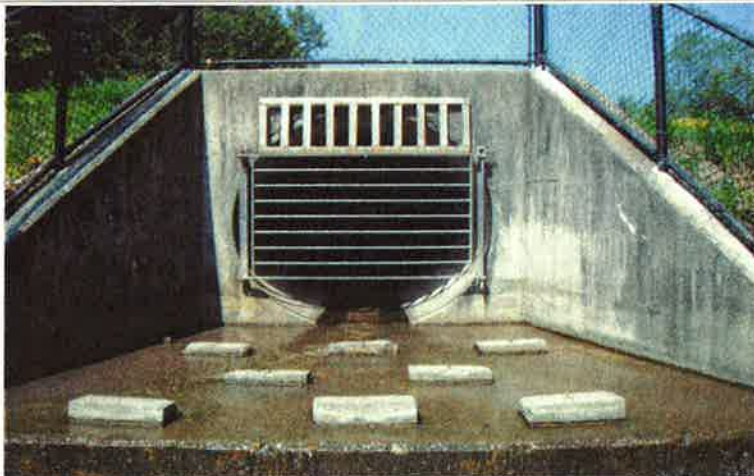
Structure Number S-9035 **Easting** 710627 **Northing** 4905654 **Stream Type** Cold
Stream Name Harper Creek **Location** Bridle Park located off Ramblewood Drive

Structure	Length	Year Built	Fish Observed	Public Land	<input checked="" type="checkbox"/>
Concrete Culvert	Unknown	Unknown	Yes	Private Land	<input type="checkbox"/>
Culvert 1 Rise	1.80m	Structure Condition	Good		
Culvert 1 Span	1.80m	Problem Description	Structure in good condition, no issues.		
Culvert 2 Rise	none				
Culvert 2 Span	none	Work Permitted	June 1st - September 30th	Permit Required	Yes

Photo Description Culvert outfall

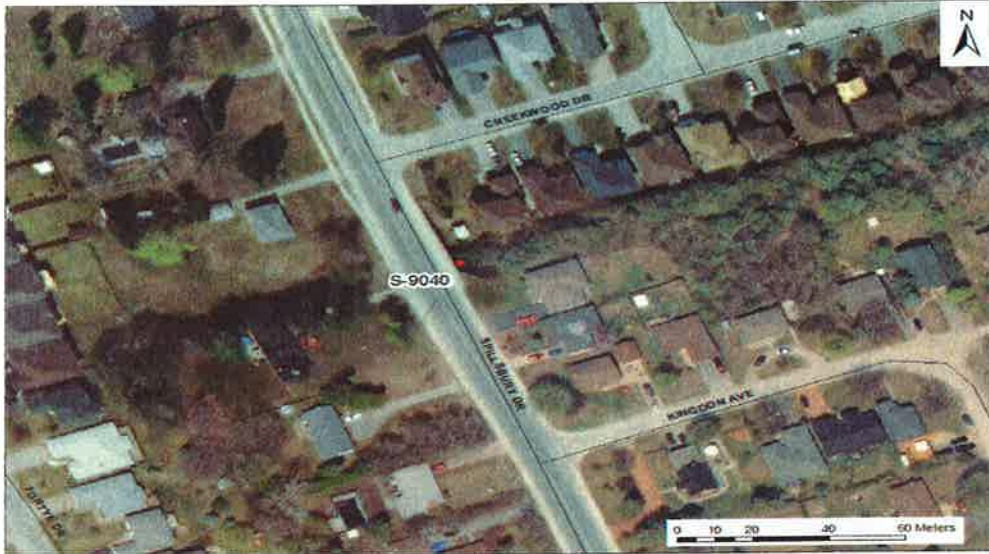
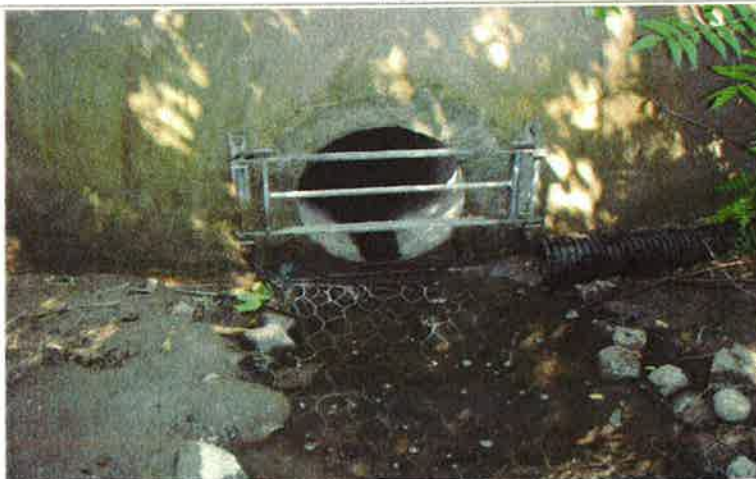
Structure Number S-9040 **Easting** 710527 **Northing** 4905386 **Stream Type** Cold
Stream Name Harper Creek **Location** Adjacent to 662 Spillsbury Drive

Structure	Length	Year Built	Fish Observed	Public Land <input checked="" type="checkbox"/>
Concrete Culvert	Unknown	Unknown	No	Private Land <input type="checkbox"/>
Culvert 1 Rise	0.60m	Structure Condition	Good	
Culvert 1 Span	0.60m	Problem Description	Structure in good condition, no issues.	
Culvert 2 Rise	none			
Culvert 2 Span	none	Work Permitted	June 1st - September 30th	Permit Required Yes

Photo Description Storm sewer outfall

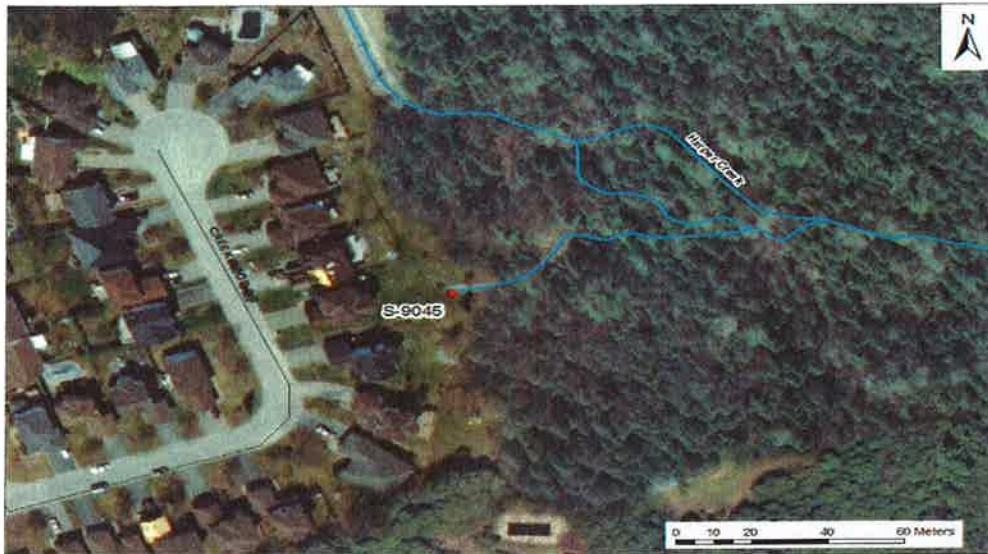
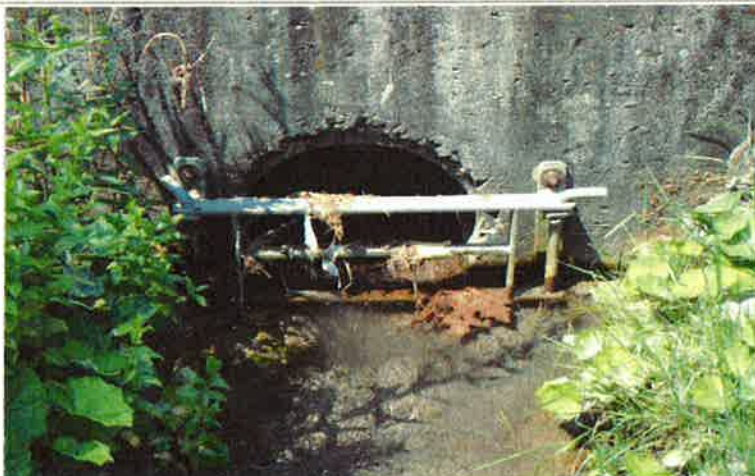
Structure Number **S-9045** Easting **710709** Northing **4905333** Stream Type **Cold**
 Stream Name **Harper Creek** Location **Between 151 and 155 Creekwood Drive**

Structure	Length	Year Built	Fish Observed	Public Land <input checked="" type="checkbox"/>
Concrete Culvert	Unknown	Unknown	Yes	Private Land <input type="checkbox"/>
Culvert 1 Rise	Structure Condition			
0.50m	Good			
Culvert 1 Span	Problem Description			
0.55m	Structure in good condition, no issues.			
Culvert 2 Rise				
none				
Culvert 2 Span	Work Permitted	Permit Required		
none	June 1st - September 30th	Yes

Photo Description Culvert outfall

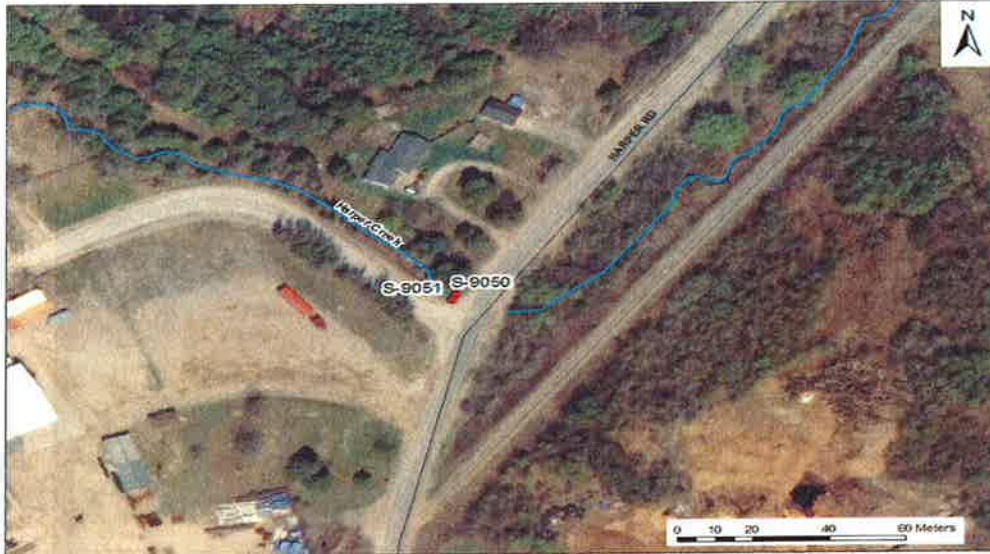
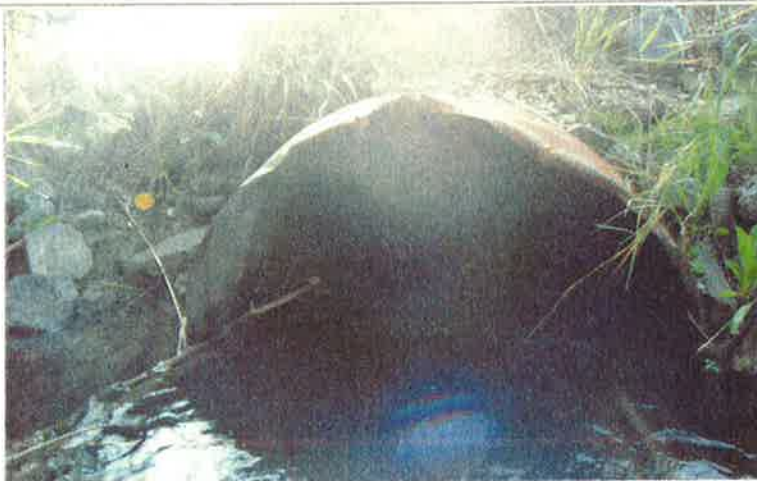
Structure Number S-9050 **Easting** 711572 **Northing** 4905563 **Stream Type** Cold
Stream Name Harper Creek **Location** Under Harper Road

Structure	Length	Year Built	Fish Observed	Public Land	<input checked="" type="checkbox"/>
CSP	12.30m	Unknown	Yes	Private Land	<input type="checkbox"/>
Culvert 1 Rise	0.90m	Structure Condition	Failing		
Culvert 1 Span	0.90m	Problem Description	Culvert rusted and collapsing under Harper Rd.		
Culvert 2 Rise	none	Work Permitted	June 1st - September 30th	Permit Required	Yes
Culvert 2 Span	none

Photo Description Culvert under Harper Road
