Harper Creek Management Plan

FINAL Report
February 2013

Prepared for the
City of Peterborough by:

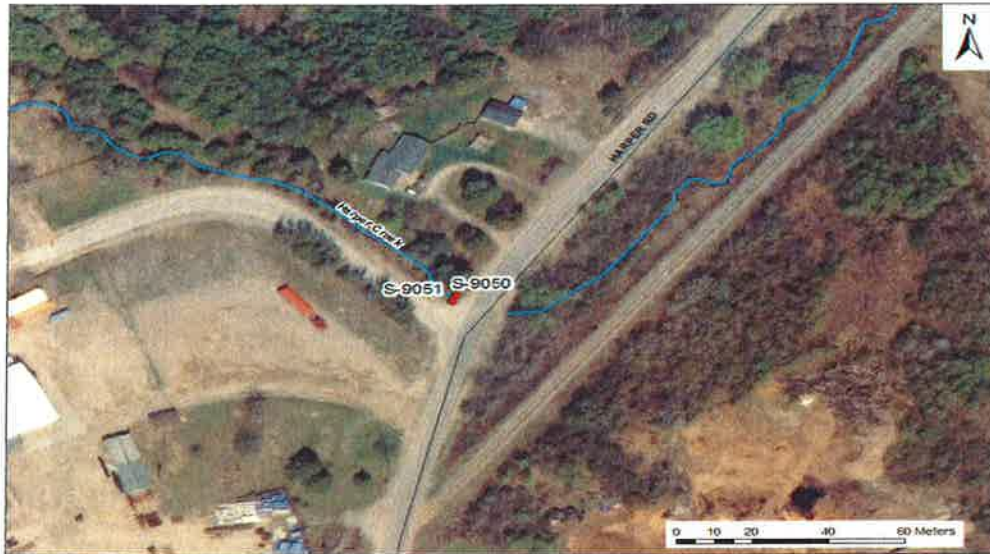
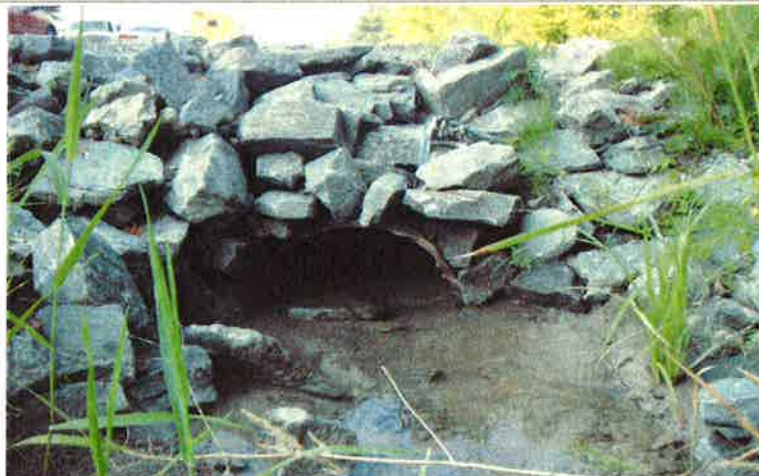
Structure Number **S-9051** Easting **711571** Northing **4905561** Stream Type **Cold**
 Stream Name **Harper Creek** Location **Driveway to City recycling yard and composting facility**

Structure	Length	Year Built	Fish Observed	Public Land	<input checked="" type="checkbox"/>
CSP	15.10m	Unknown	No	Private Land	<input type="checkbox"/>
Culvert 1 Rise	0.34m	Structure Condition	Good		
Culvert 1 Span	0.40m	Problem Description	Structure in good condition, no issues.		
Culvert 2 Rise	none				
Culvert 2 Span	none	Work Permitted	June 1st - September 30th	Permit Required	Yes

Photo Description Ditch drainage culvert

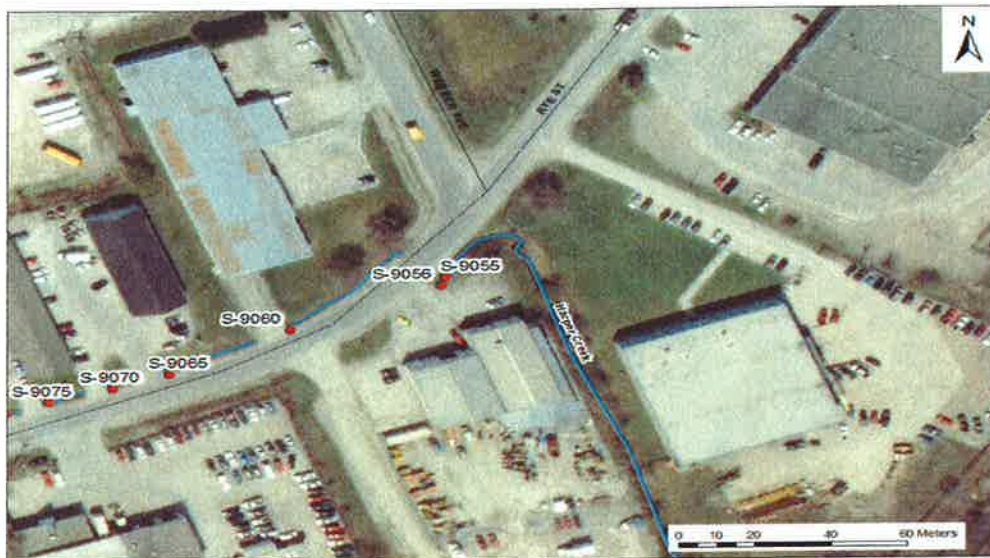
Structure Number S-9055 **Easting** 711804 **Northing** 4906164 **Stream Type** Cold
Stream Name Harper Creek **Location** Adjacent to 740 Rye Street (Rapid Lift)

Structure	Length	Year Built	Fish Observed	Public Land	<input checked="" type="checkbox"/>
CSP	12.80m	Unknown	Yes	Private Land	<input type="checkbox"/>
Culvert 1 Rise	0.40m	Structure Condition	Adequate		
Culvert 1 Span	1.00m	Problem Description	Culvert has high sediment build up. Clean out required.		
Culvert 2 Rise	none				
Culvert 2 Span	none	Work Permitted	June 1st - September 30th	Permit Required	Yes

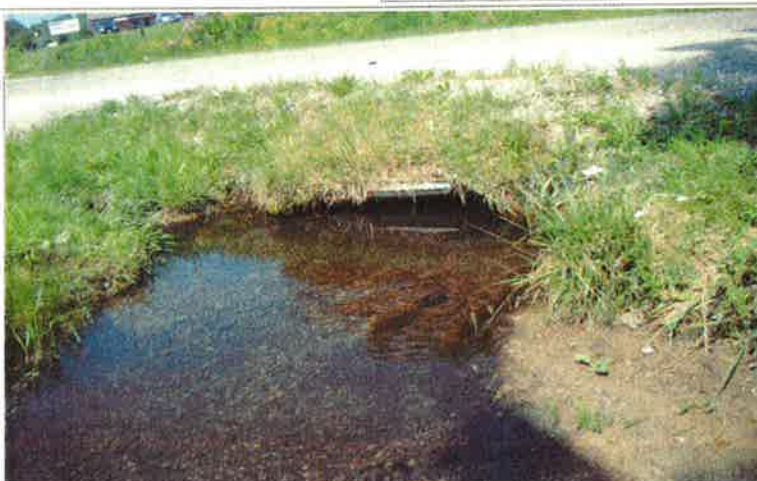
Photo Description Culvert under Rye Street

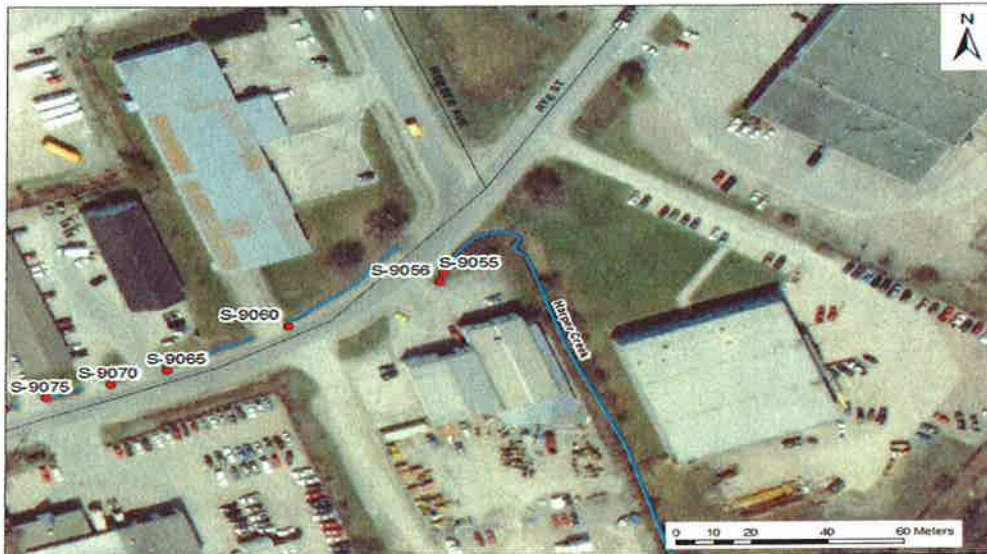
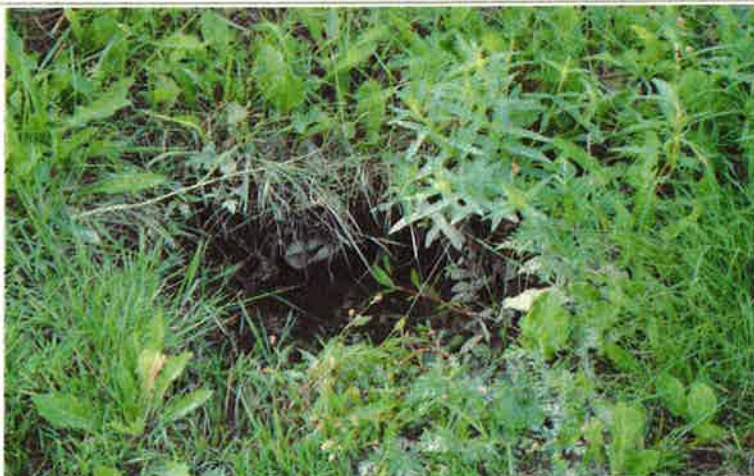
Structure Number S-9056 **Easting** 711803 **Northing** 4906161 **Stream Type** Cold
Stream Name Harper Creek **Location** 740 Rye Street (Rapid Lift)

Structure	Length	Year Built	Fish Observed	Public Land
CSP	17.30m	Unknown	No	<input type="checkbox"/>
Culvert 1 Rise	0.30m	Structure Condition	Good	
Culvert 1 Span	0.30m	Problem Description	Structure in good condition, no issues.	
Culvert 2 Rise	none			
Culvert 2 Span	none	Work Permitted	June 1st - September 30th	Permit Required Yes

Photo Description Driveway ditch culvert

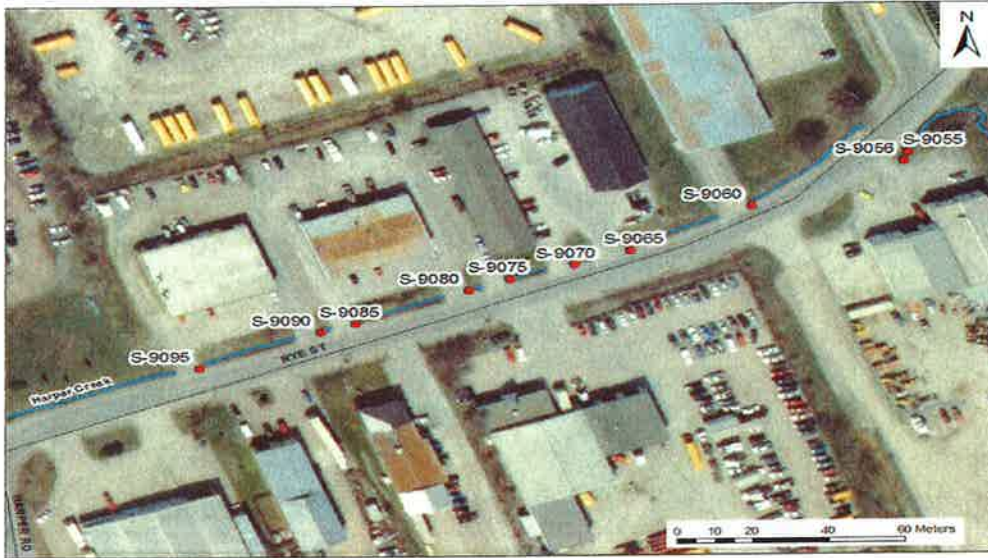
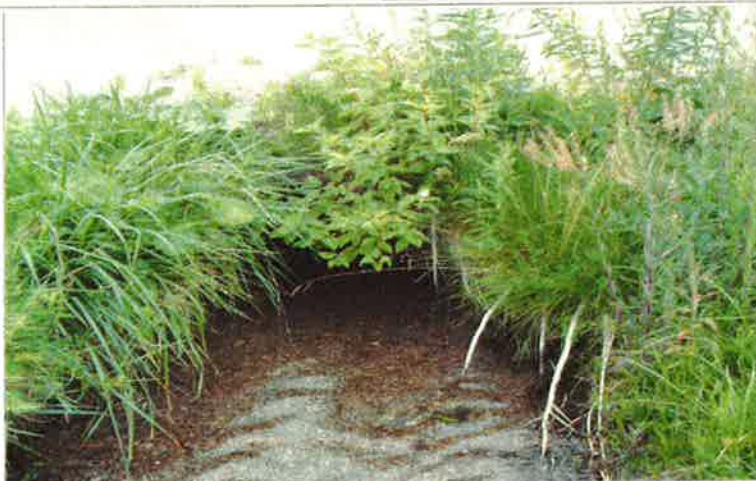
Structure Number S-9060 **Easting** 711763 **Northing** 4906145 **Stream Type** Cold
Stream Name Harper Creek **Location** 771 Webber Avenue (rear driveway entrance for National Sanitation and Supply Company Limited)

Structure	Length	Year Built	Fish Observed	Public Land <input checked="" type="checkbox"/>
CSP	9.90m	Unknown	Yes	Private Land <input type="checkbox"/>
Culvert 1 Rise	0.60m	Structure Condition	Good	
Culvert 1 Span	1.00m	Problem Description	Structure in good condition, no issues.	
Culvert 2 Rise	none			
Culvert 2 Span	none	Work Permitted	June 1st - September 30th	Permit Required Yes

Photo Description Driveway ditch culvert

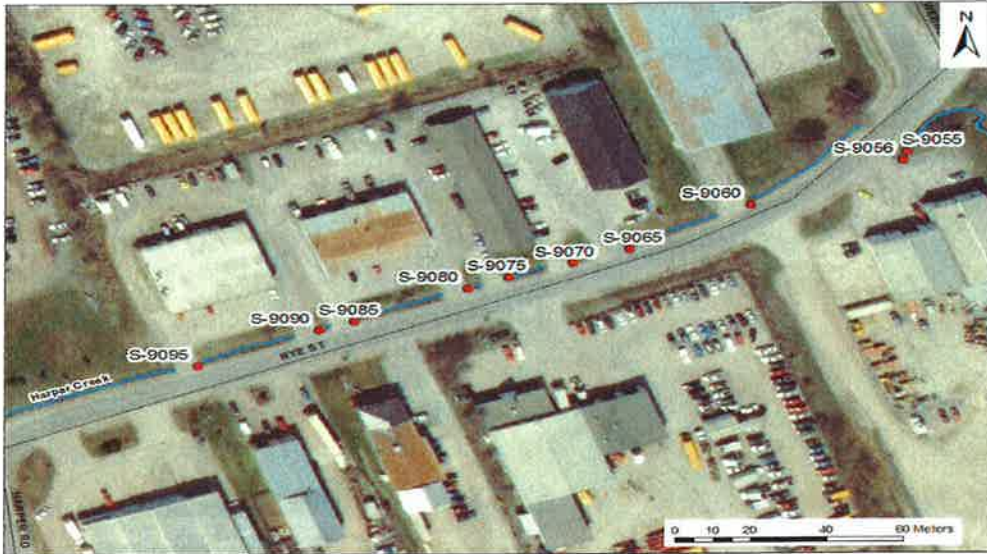
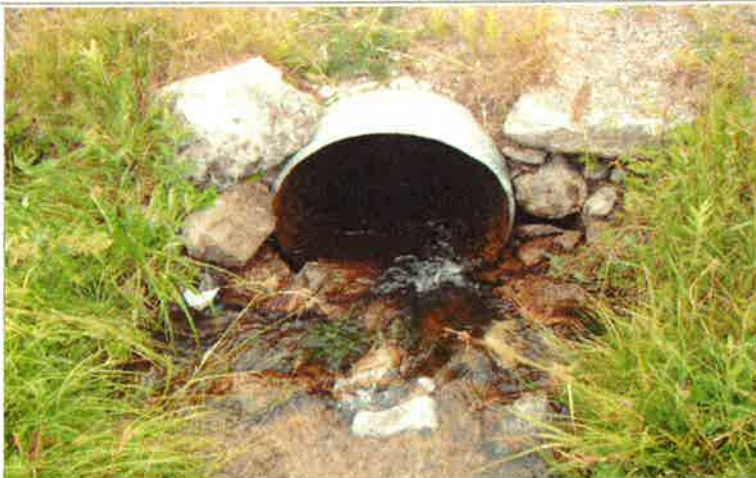
Structure Number S-9065 **Easting** 711731 **Northing** 4906129 **Stream Type** Cold
Stream Name Harper Creek **Location** 731 Rye Street (entrance to Norm's Cash and Carry)

Structure	Length	Year Built	Fish Observed	Public Land	<input checked="" type="checkbox"/>
CSP	9.10m	Unknown	Yes	Private Land	<input type="checkbox"/>
Culvert 1 Rise	0.60m	Structure Condition	Good		
Culvert 1 Span	0.60m	Problem Description	Structure in good condition, no issues.		
Culvert 2 Rise	none				
Culvert 2 Span	none	Work Permitted	June 1st - September 30th	Permit Required	Yes

Photo Description Driveway ditch culvert

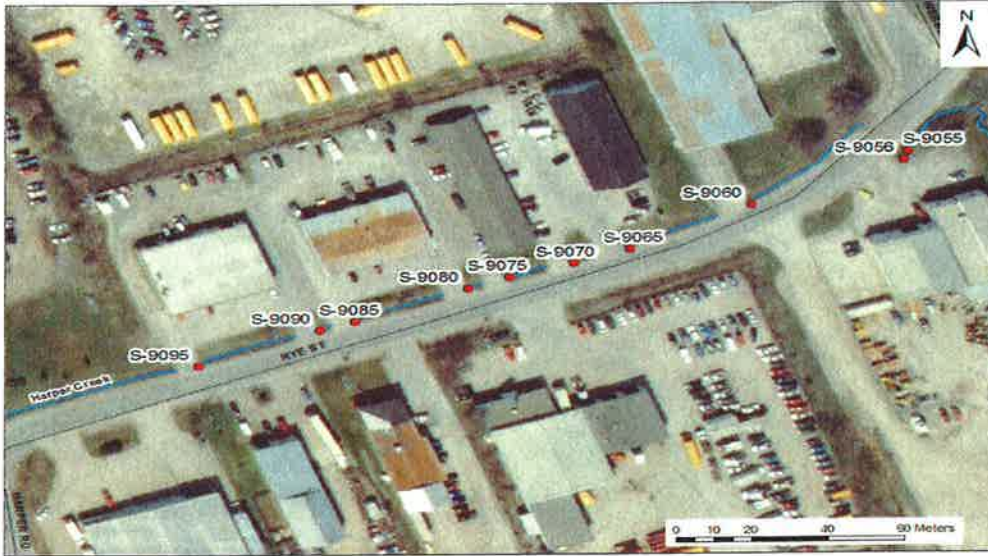
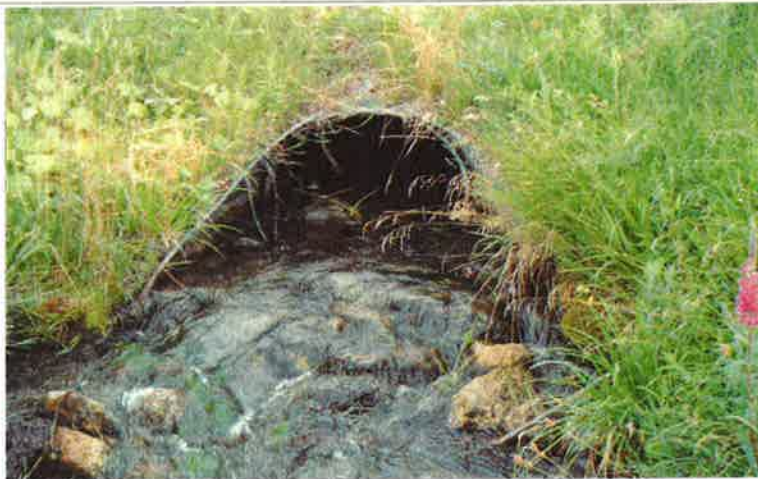
Structure Number S-9070 Easting 711716 Northing 4906124 Stream Type Cold
Stream Name Harper Creek Location 721 Rye Street

Structure	Length	Year Built	Fish Observed	Public Land	<input checked="" type="checkbox"/>
CSP	6.80m	Unknown	Yes	Private Land	<input type="checkbox"/>
Culvert 1 Rise	<u>0.50m</u>	Structure Condition	<u>Good</u>		
Culvert 1 Span	<u>0.65m</u>	Problem Description	<u>Structure in good condition, no issues.</u>		
Culvert 2 Rise	<u>none</u>				
Culvert 2 Span	<u>none</u>	Work Permitted	<u>June 1st - September 30th</u>	Permit Required	<u>Yes</u>

Photo Description Driveway ditch culvert

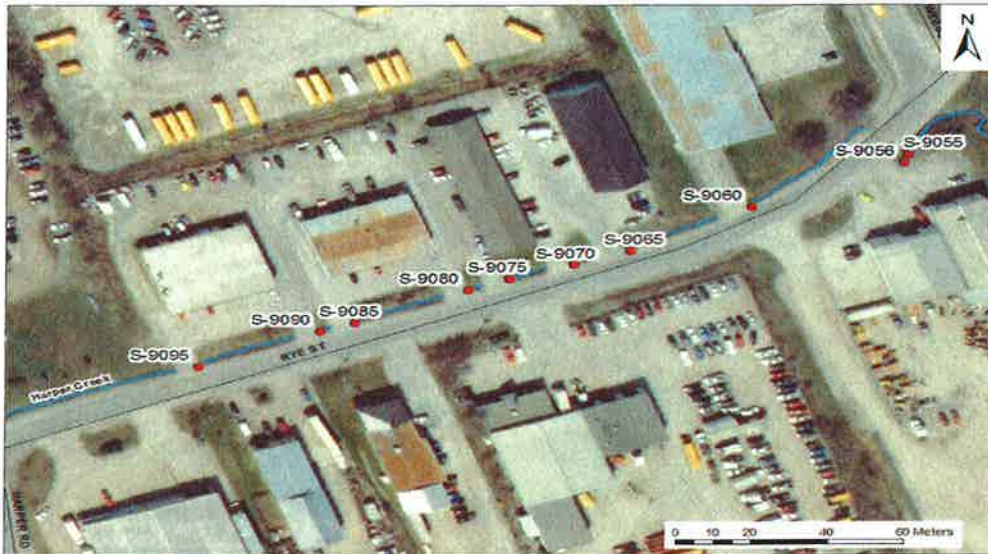
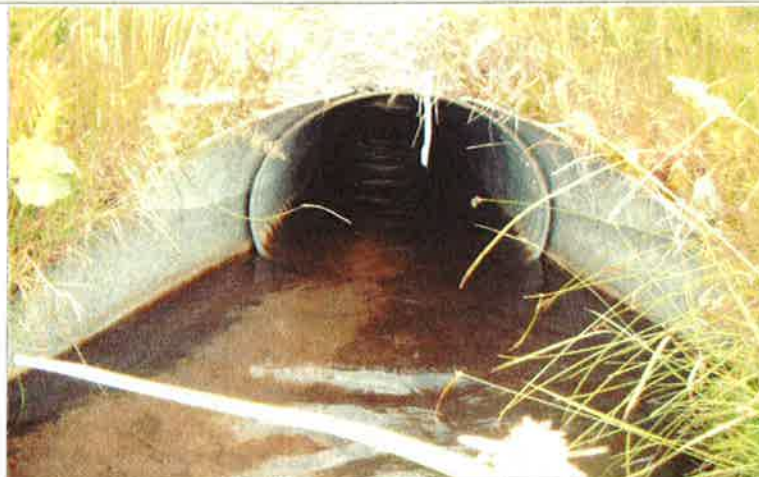
Structure Number S-9075 Easting 711699 Northing 4906119 Stream Type Cold
 Stream Name Harper Creek Location 721 Rye Street

Structure	Length	Year Built	Fish Observed	Public Land	<input checked="" type="checkbox"/>
CSP	6.90m	Unknown	Yes	Private Land	<input type="checkbox"/>
Culvert 1 Rise	<u>0.65m</u>	Structure Condition	<u>Good</u>		
Culvert 1 Span	<u>0.65m</u>	Problem Description	<u>Structure in good condition, no issues.</u>		
Culvert 2 Rise	<u>none</u>				
Culvert 2 Span	<u>none</u>	Work Permitted	<u>June 1st - September 30th</u>	Permit Required	<u>Yes</u>

Photo Description Driveway ditch culvert

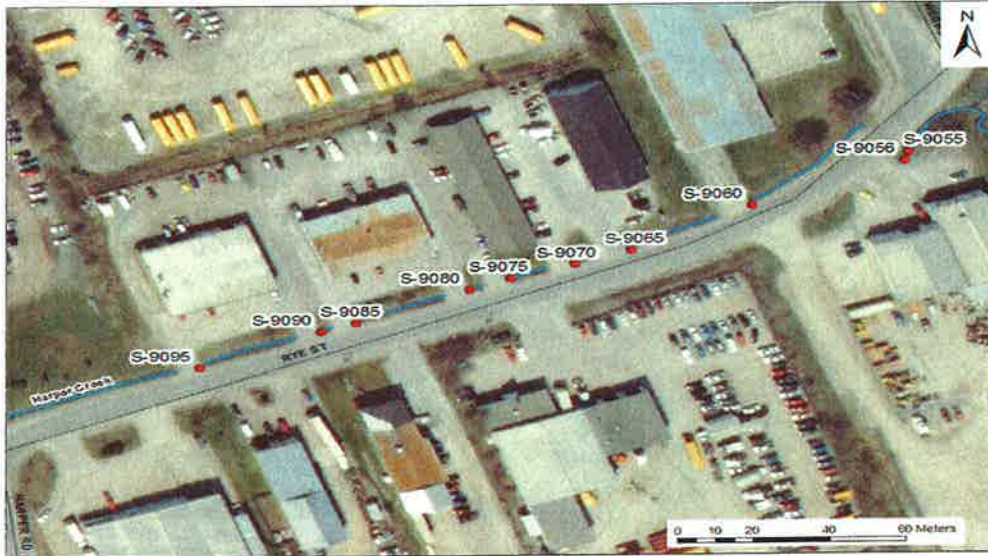
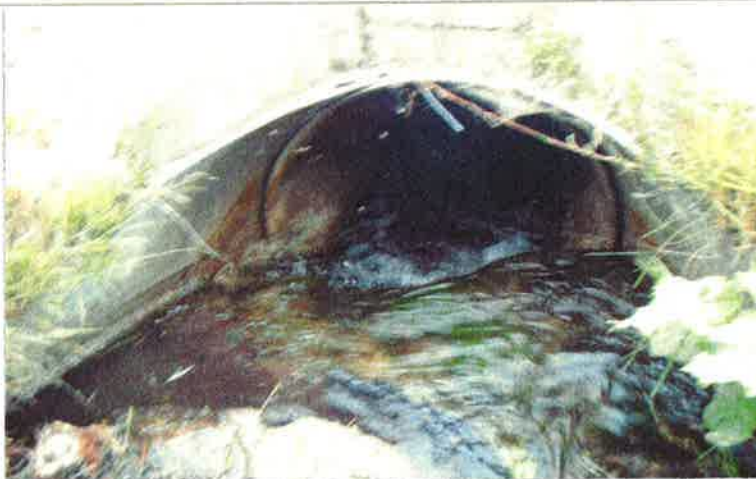
Structure Number S-9080 **Easting** 711688 **Northing** 4906115 **Stream Type** Cold
Stream Name Harper Creek **Location** 711 Rye Street

Structure	Length	Year Built	Fish Observed	Public Land <input checked="" type="checkbox"/>
CSP	8.50m	Unknown	Yes	Private Land <input type="checkbox"/>
Culvert 1 Rise	0.65m	Structure Condition	Good	
Culvert 1 Span	0.65m	Problem Description	Structure in good condition, no issues.	
Culvert 2 Rise	none			
Culvert 2 Span	none	Work Permitted	June 1st - September 30th	Permit Required Yes

Photo Description Driveway ditch culvert

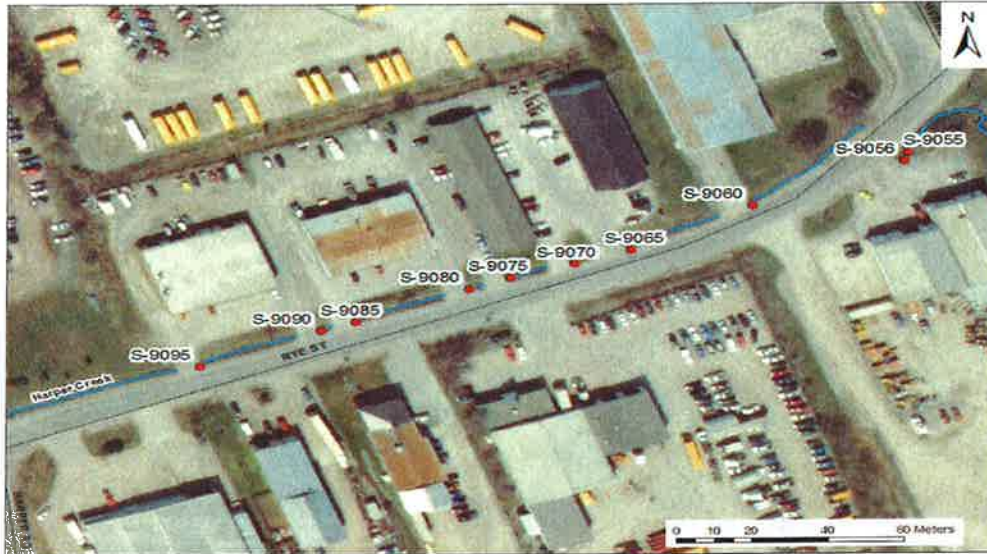
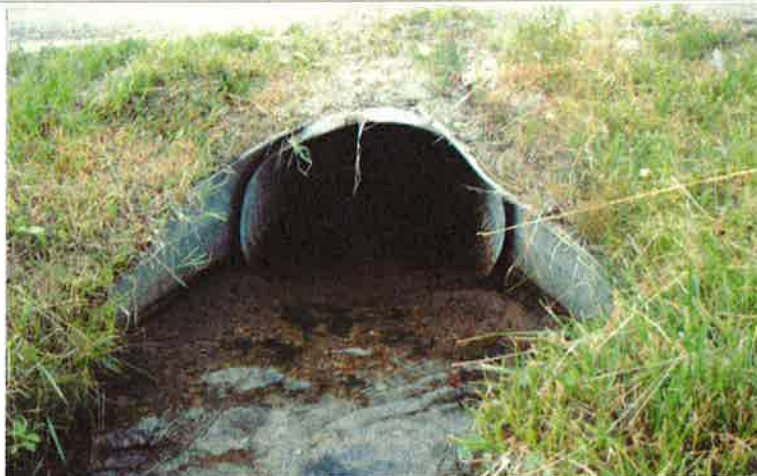
Structure Number **S-9085** Easting **711658** Northing **4906103** Stream Type **Cold**
 Stream Name **Harper Creek** Location **711 Rye Street**

Structure	Length	Year Built	Fish Observed	Public Land	<input checked="" type="checkbox"/>
CSP	6.90m	Unknown	Yes	Private Land	<input type="checkbox"/>
Culvert 1 Rise	0.65m	Structure Condition	Good		
Culvert 1 Span	0.65m	Problem Description	Structure in good condition, no issues.		
Culvert 2 Rise	none				
Culvert 2 Span	none	Work Permitted	June 1st - September 30th	Permit Required	Yes

Photo Description Driveway ditch culvert

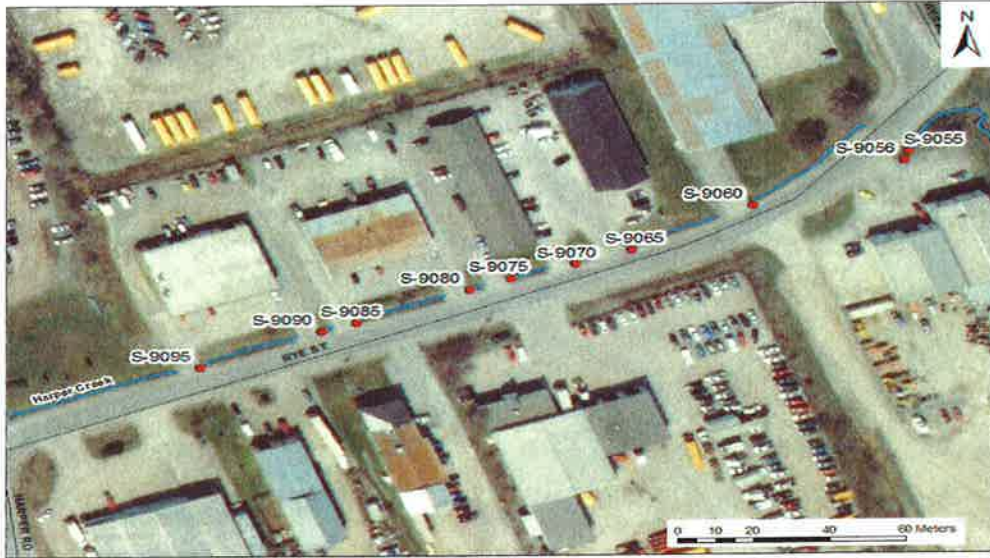
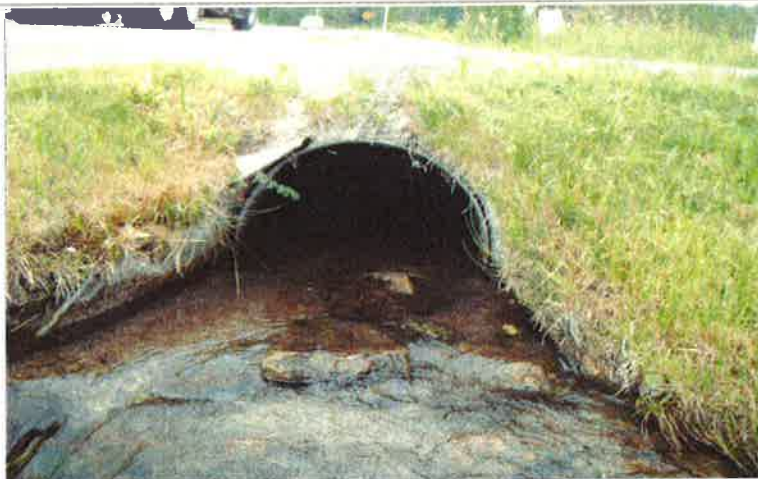
Structure Number S-9090 **Easting** 711649 **Northing** 4906100 **Stream Type** Cold
Stream Name Harper Creek **Location** 705 Rye Street

Structure	Length	Year Built	Fish Observed	Public Land	<input checked="" type="checkbox"/>
CSP	8.05m	Unknown	Yes	Private Land	<input type="checkbox"/>
Culvert 1 Rise	0.65m	Structure Condition	Good		
Culvert 1 Span	0.65m	Problem Description	Structure in good condition, no issues.		
Culvert 2 Rise	none				
Culvert 2 Span	none	Work Permitted	June 1st - September 30th	Permit Required	Yes

Photo Description Driveway ditch culvert

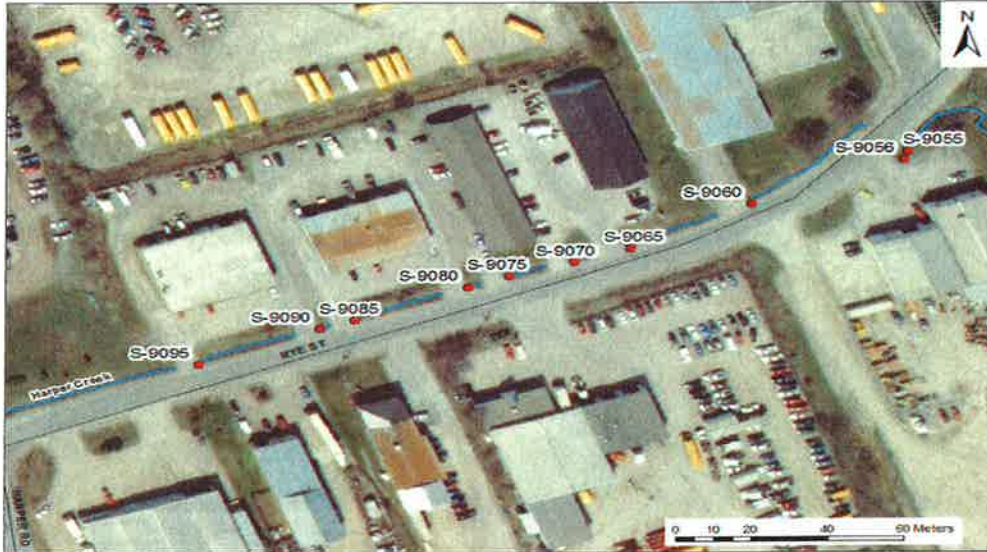
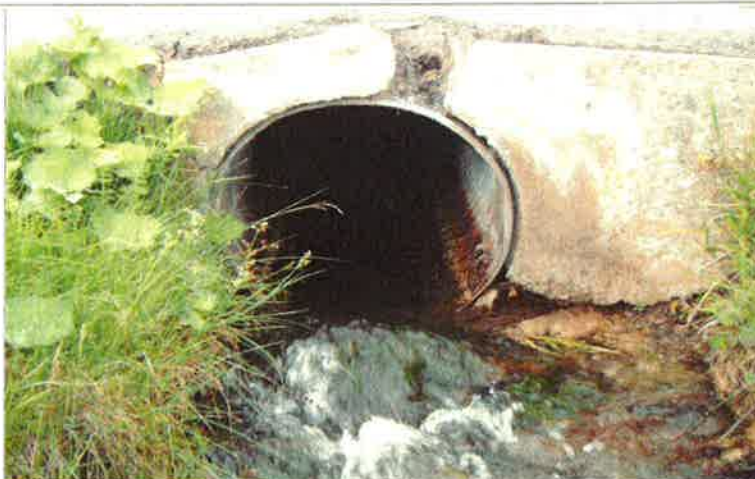
Structure Number S-9095 **Easting** 711617 **Northing** 4906087 **Stream Type** Cold
Stream Name Harper Creek **Location** 705 Rye Street

Structure	Length	Year Built	Fish Observed	Public Land	<input checked="" type="checkbox"/>
CSP	7.10m	Unknown	Yes	Private Land	<input type="checkbox"/>
Culvert 1 Rise	0.60m	Structure Condition	Failing		
Culvert 1 Span	0.60m	Problem Description	Holes present in corroded culvert.		
Culvert 2 Rise	none				
Culvert 2 Span	none	Work Permitted	June 1st - September 30th	Permit Required	Yes

Photo Description Driveway ditch culvert

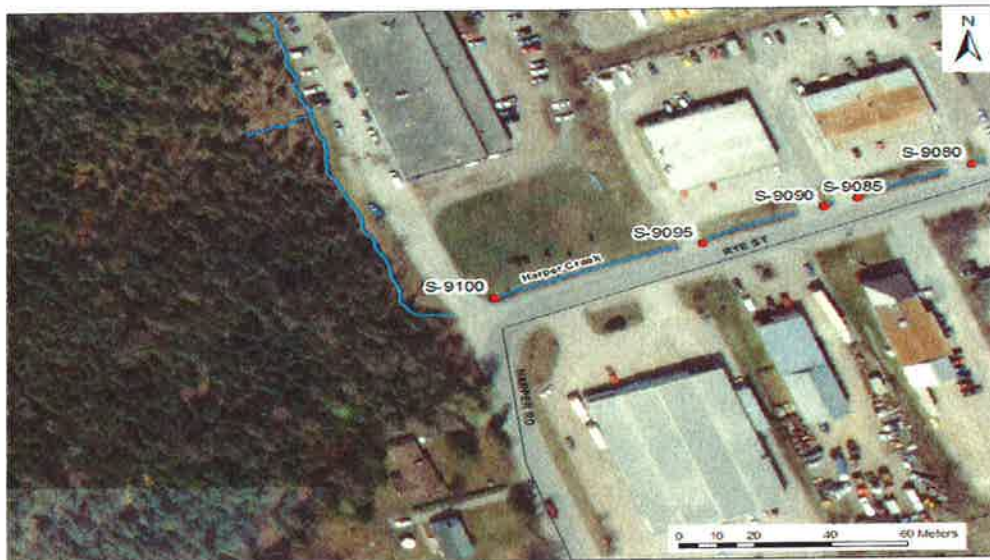
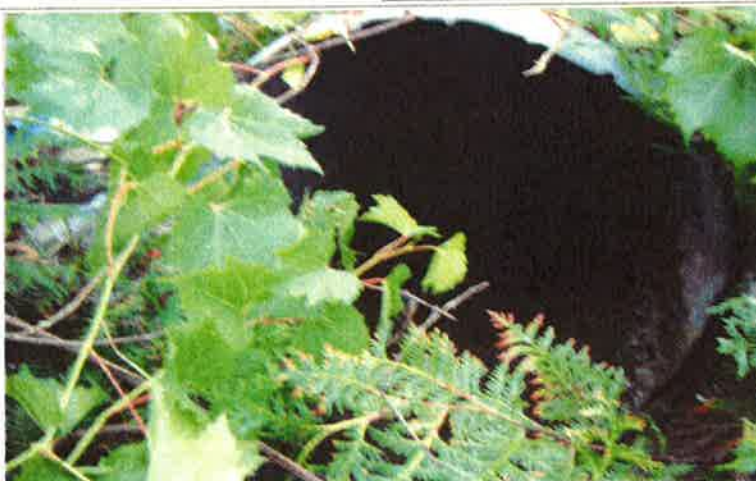
Structure Number S-9100 **Easting** 711562 **Northing** 4906068 **Stream Type** Cold
Stream Name Harper Creek **Location** 687 Rye Street

Structure	Length	Year Built	Fish Observed	Public Land	<input checked="" type="checkbox"/>
CSP	13.90m	Unknown	Yes	Private Land	<input type="checkbox"/>
Culvert 1 Rise	0.65m	Structure Condition	Good		
Culvert 1 Span	0.65m	Problem Description	Structure in good condition, no issues.		
Culvert 2 Rise	none				
Culvert 2 Span	none	Work Permitted	June 1st - September 30th	Permit Required	Yes

Photo Description Driveway ditch culvert

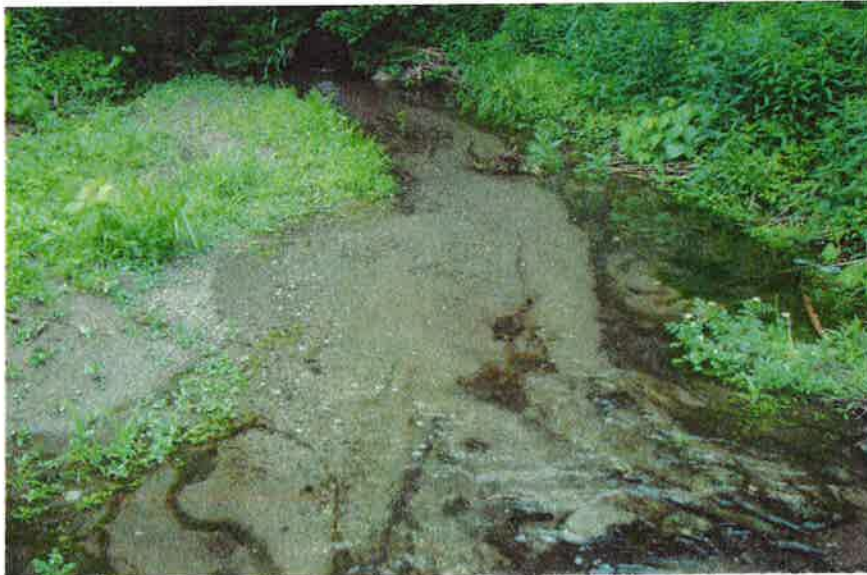
Sediment buildup downstream of Pinewood Drive June 2012

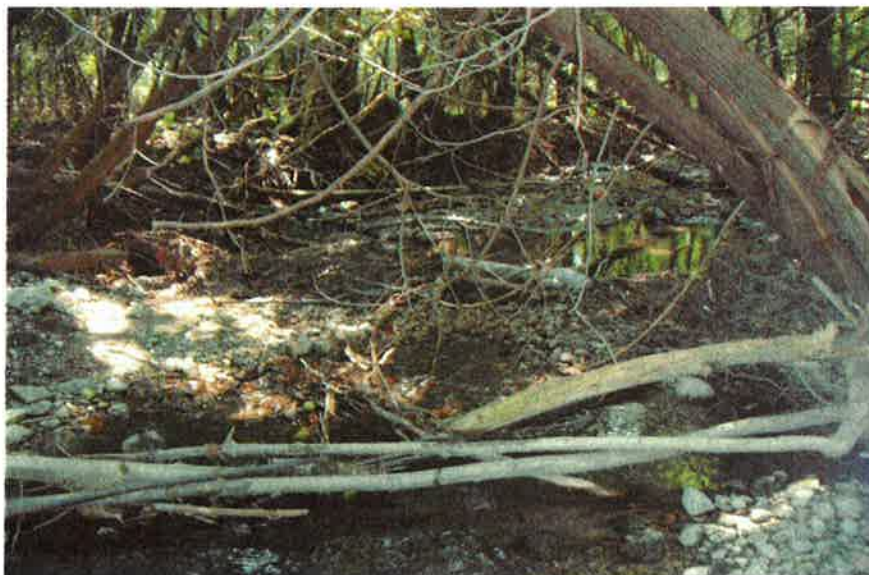
Woody debris and boulder build up.

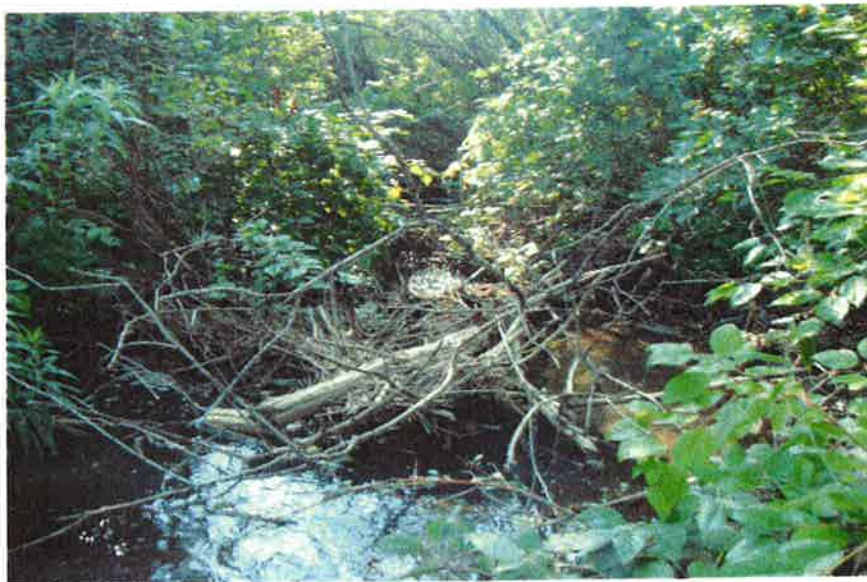
Debris build up.

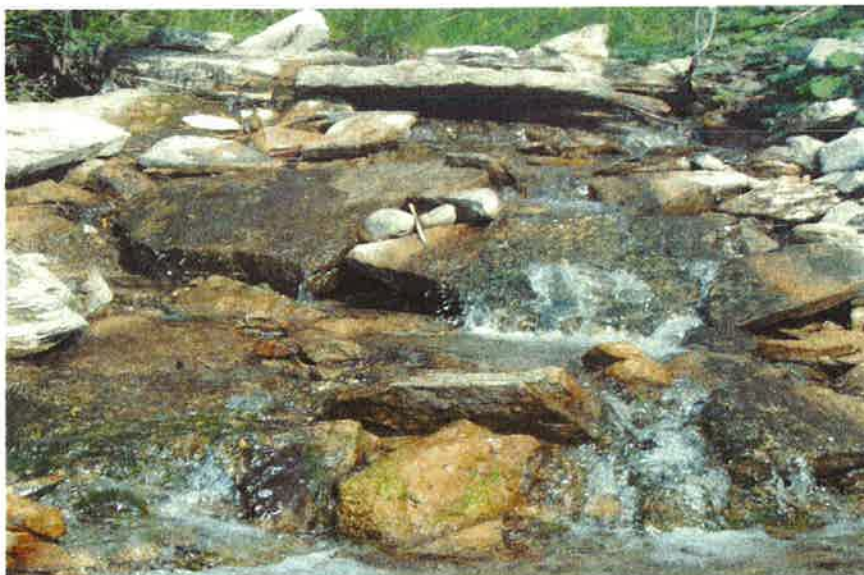
Outlet of Harper Creek into Byersville Creek.

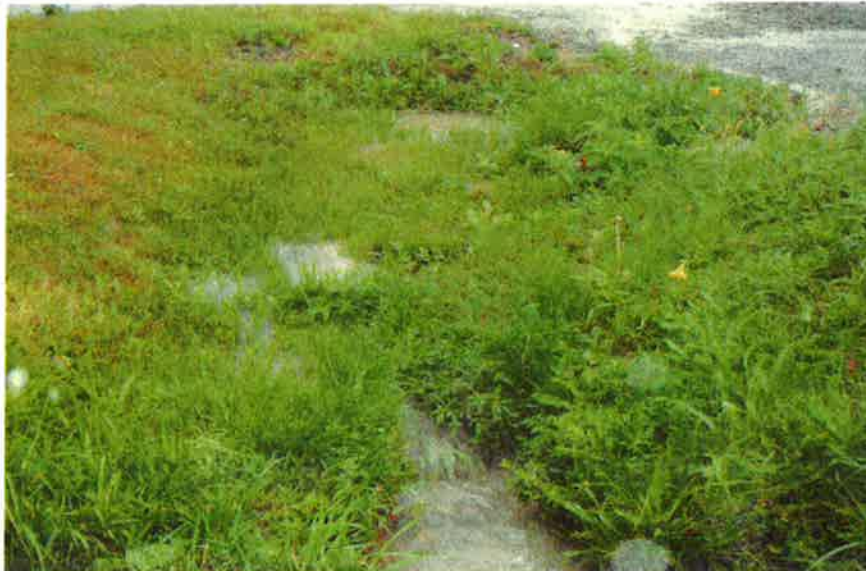
Sediment build in ditch.

Re-orienting the culvert to allow for more natural flow patterns may reduce concerns at this location. Natural channel design and bioengineering could re-orient flows to prevent erosion downstream of the culvert and enhance shading and fish habitat conditions along this section of Harper Creek. Replacing the Harper Road and Webber Avenue culvert with an open-bottom culvert would provide natural substrates and allow groundwater flows to reach the creek channel.

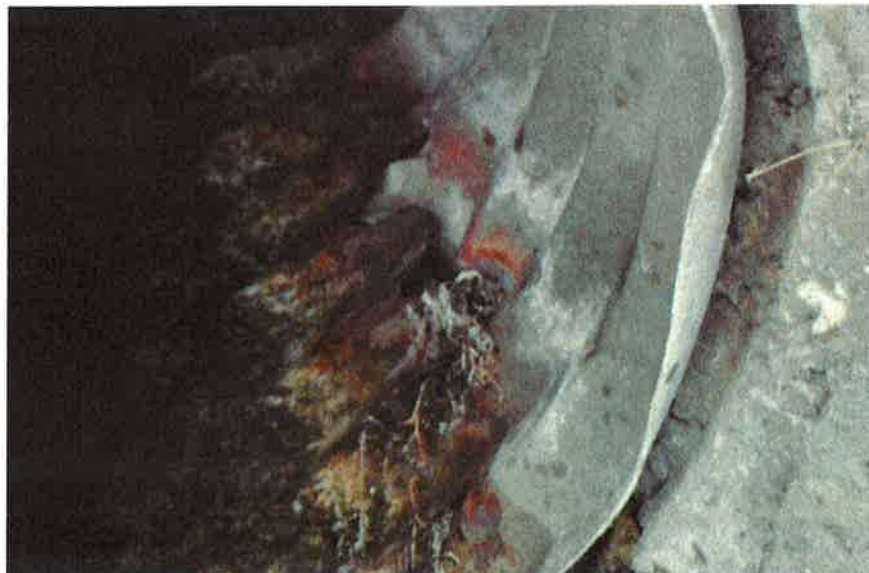
There are holes in the culvert which allow water to flow through create conditions for erosion of the driveway or shoulder of the road.

Holes in culvert.

Replace culvert.
